Initial Safety Factor Assessment Jeffrey Energy Center Inactive Bottom Ash Pond

Prepared for:
Westar Energy
Jeffrey Energy Center
St. Marys, Kansas

Prepared by:
APTIM Environmental & Infrastructure, Inc.

April 2018

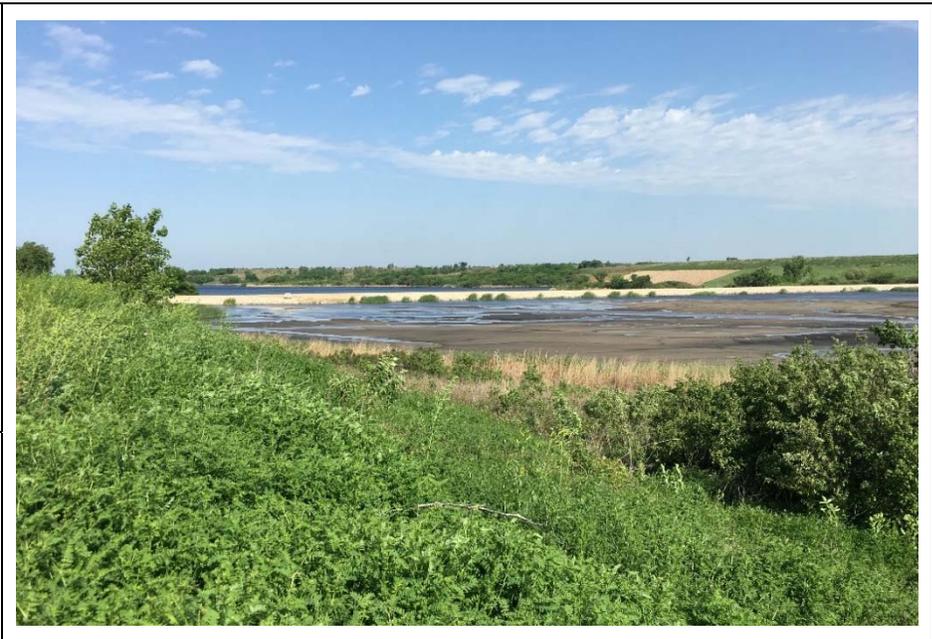
<p>Photograph No. 1</p> <p>Date: May 16, 2017</p> <p>Direction: Northwest</p>

<p>Description: Observing Bottom Ash Pond and the surrounding vegetation on the south slope.</p>

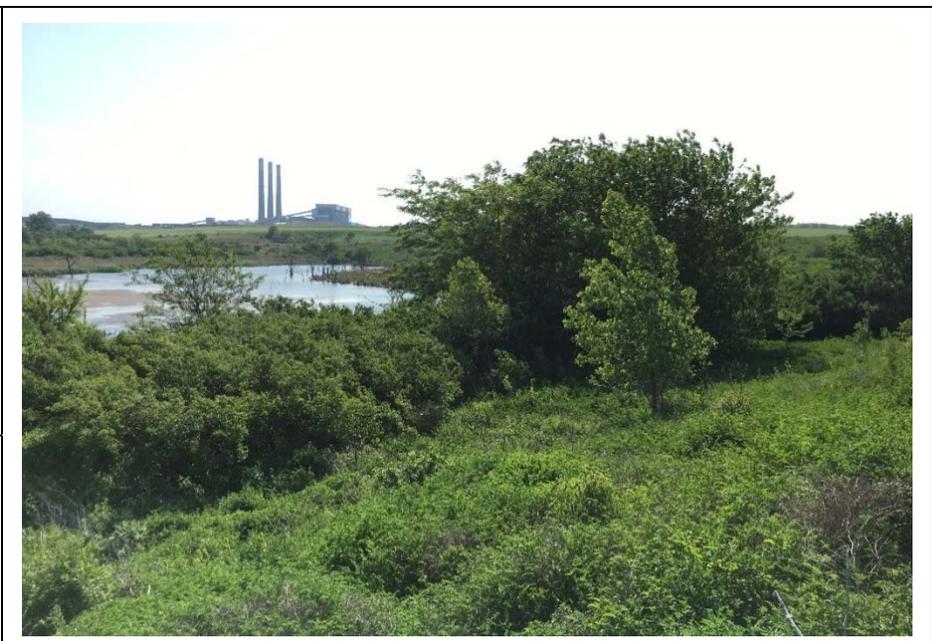
<p>Photograph No. 2</p> <p>Date: May 16, 2017</p> <p>Direction: Northeast</p>

<p>Description: Observing the eastern edge of the Bottom Ash Pond. Vegetation is well established.</p>

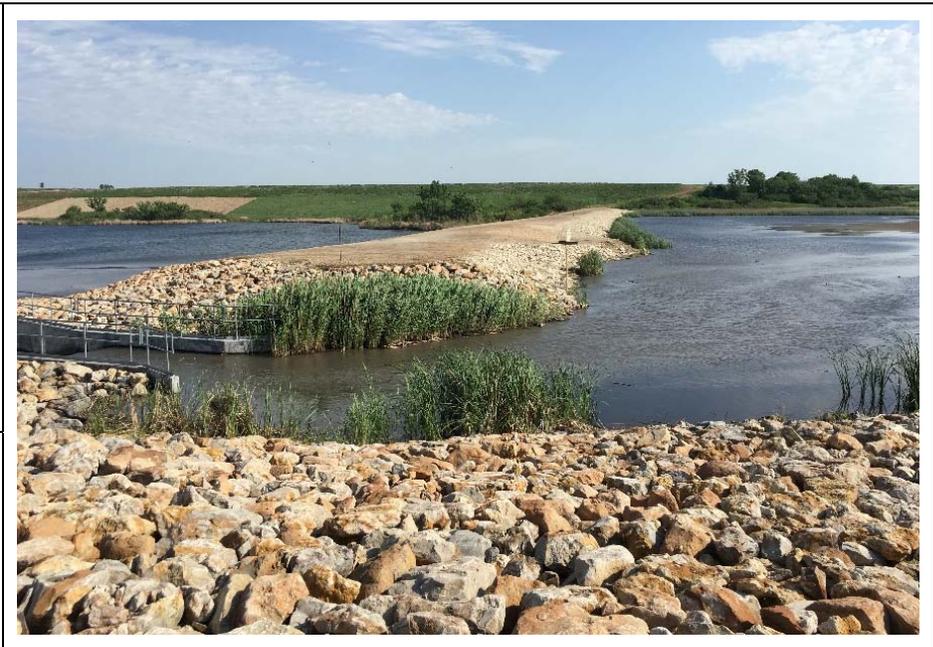
<p>Photograph No. 3</p> <p>Date: May 16, 2017</p> <p>Direction: North</p>

<p>Description: Looking at spillway and dam between the Bottom Ash Pond and Tower Hill Lake. Slopes are rip-rap lined. Some vegetation. No noticeable erosion.</p>

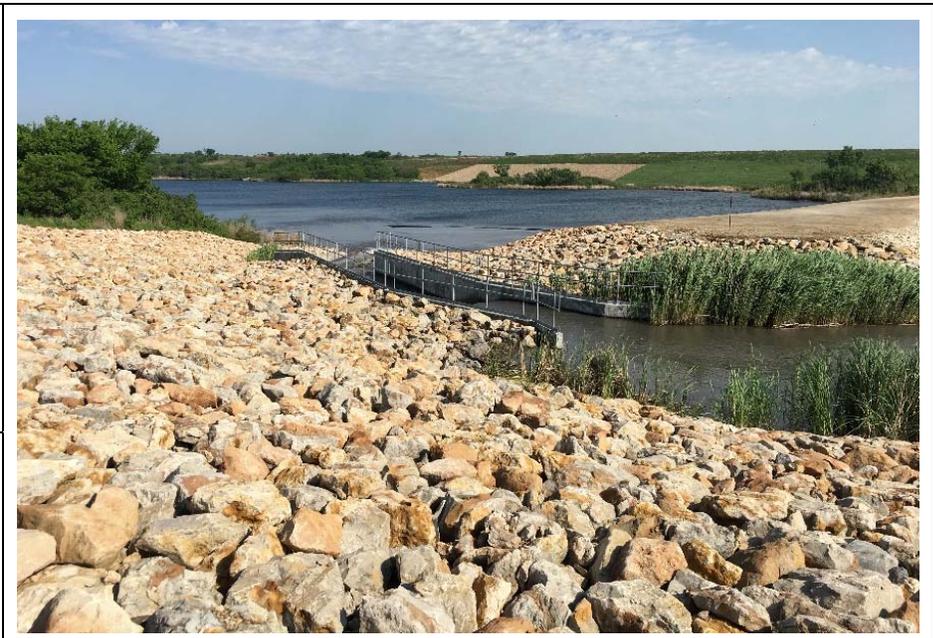
<p>Photograph No. 4</p> <p>Date: May 16, 2017</p> <p>Direction: Northwest</p>

<p>Description: Looking at spillway from Bottom Ash Pond to Tower Hill Lake. No evidence of erosion or malfunction.</p>

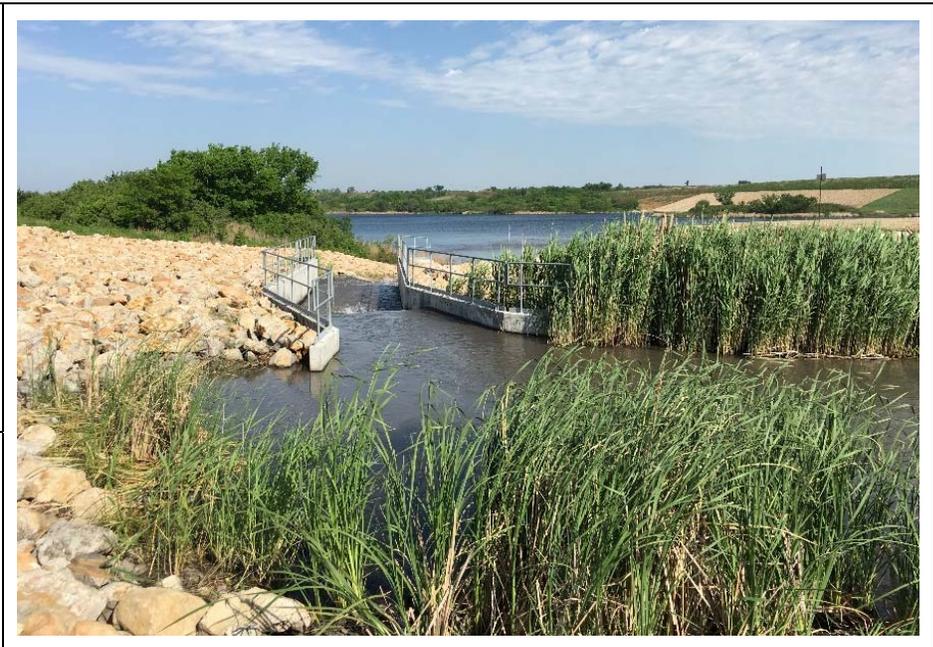
<p>Photograph No. 5</p> <p>Date: May 16, 2017</p> <p>Direction: Northwest</p>

<p>Description: Looking at spillway from Bottom Ash Pond to Tower Hill Lake. No evidence of erosion or malfunction. Some vegetation present.</p>

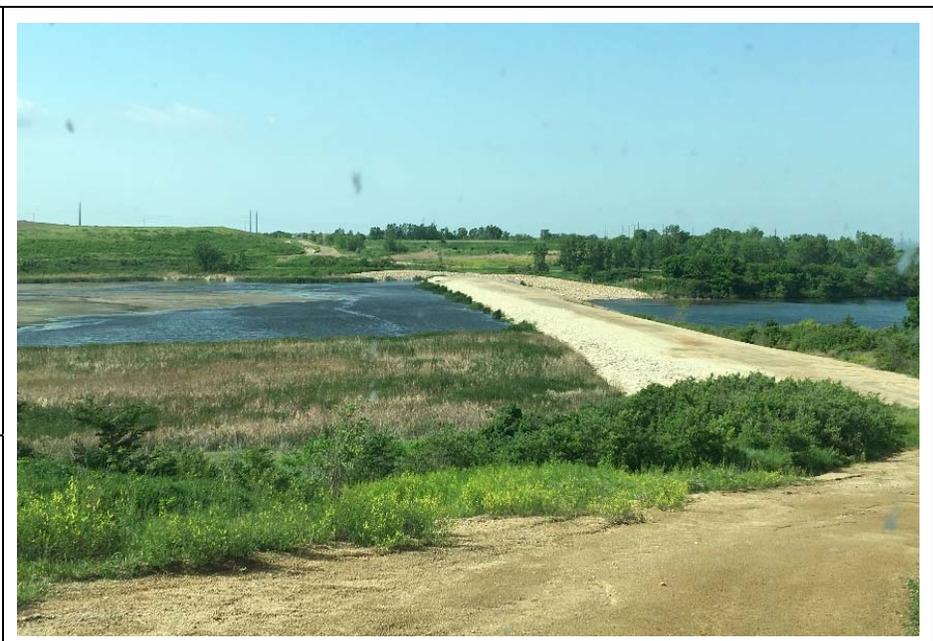
<p>Photograph No. 6</p> <p>Date: May 16, 2017</p> <p>Direction: Southwest</p>

<p>Description: Looking at the dam from the access road crossing. No evidence of erosion or distress. Established vegetation present.</p>

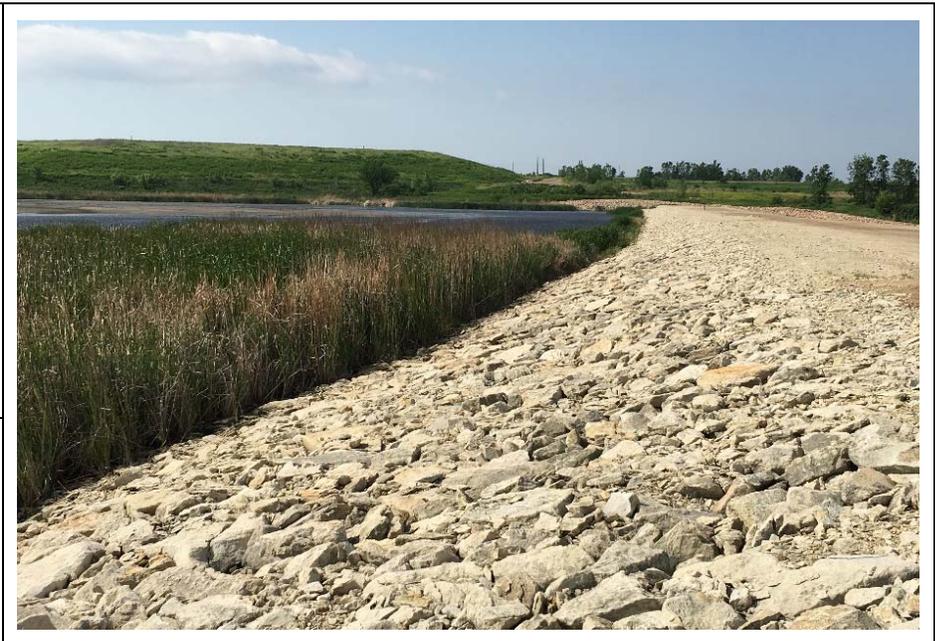
<p>Photograph No. 7</p> <p>Date: May 16, 2017</p> <p>Direction: Southwest</p>

<p>Description: Observing the upstream side of the dam separating the Bottom Ash Pond and Tower Hill Lake. No significant erosion. Established vegetation present.</p>

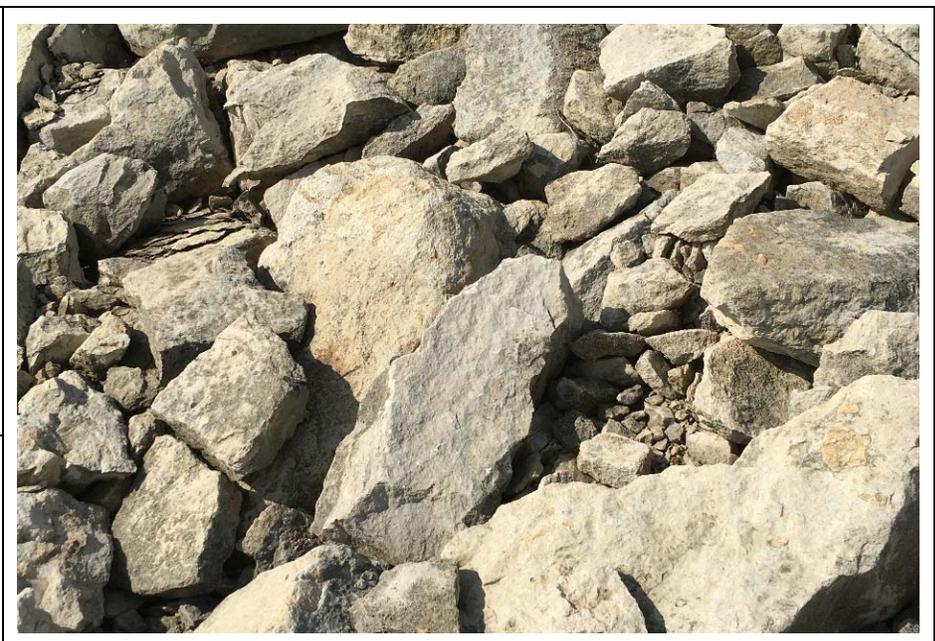
<p>Photograph No. 8</p> <p>Date: May 16, 2017</p> <p>Direction: -</p>

<p>Description: Observing rip-rap present on the upstream slope of the dam.</p>

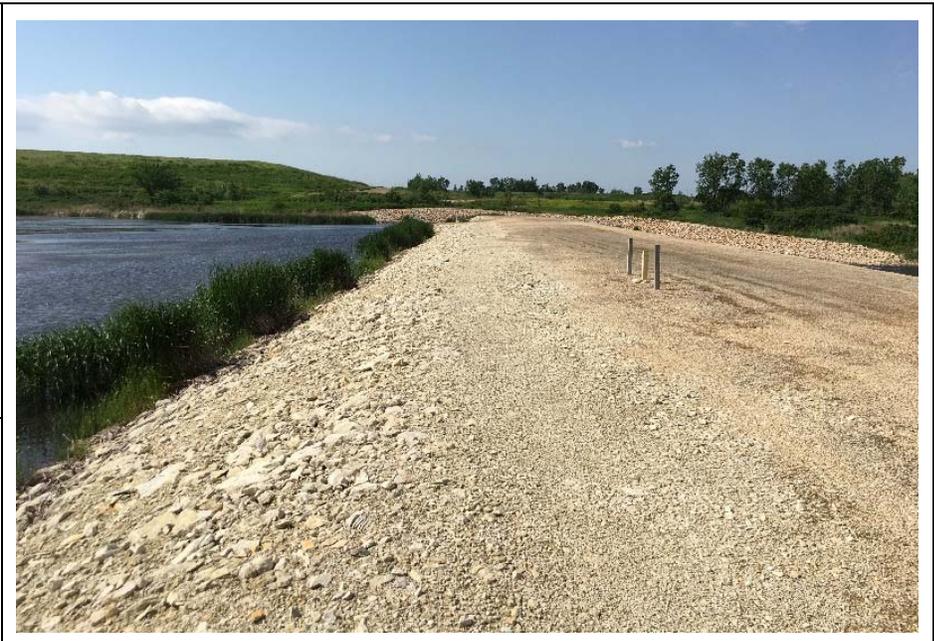
<p>Photograph No. 9</p> <p>Date: May 16, 2017</p> <p>Direction: Southwest</p>

<p>Description: Observing the dam separating the Bottom Ash Pond and Tower Hill Lake on the downstream slope. No significant erosion present. Established vegetation present.</p>

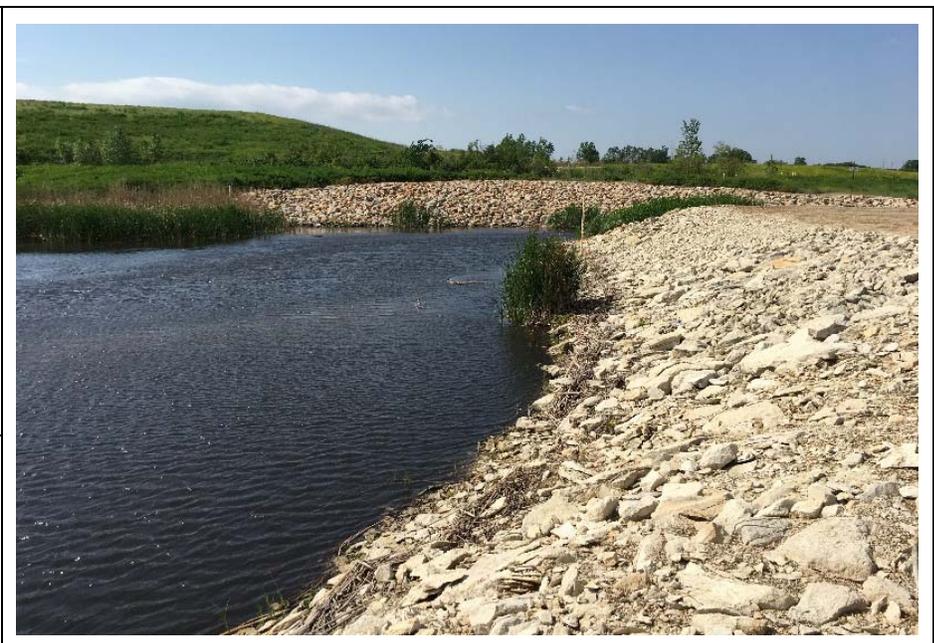
<p>Photograph No. 10</p> <p>Date: May 16, 2017</p> <p>Direction: Southwest</p>

<p>Description: Observing the berm separating the Bottom Ash Pond and Tower Hill Pond on the upstream slope. No significant erosion present. Established vegetation present.</p>

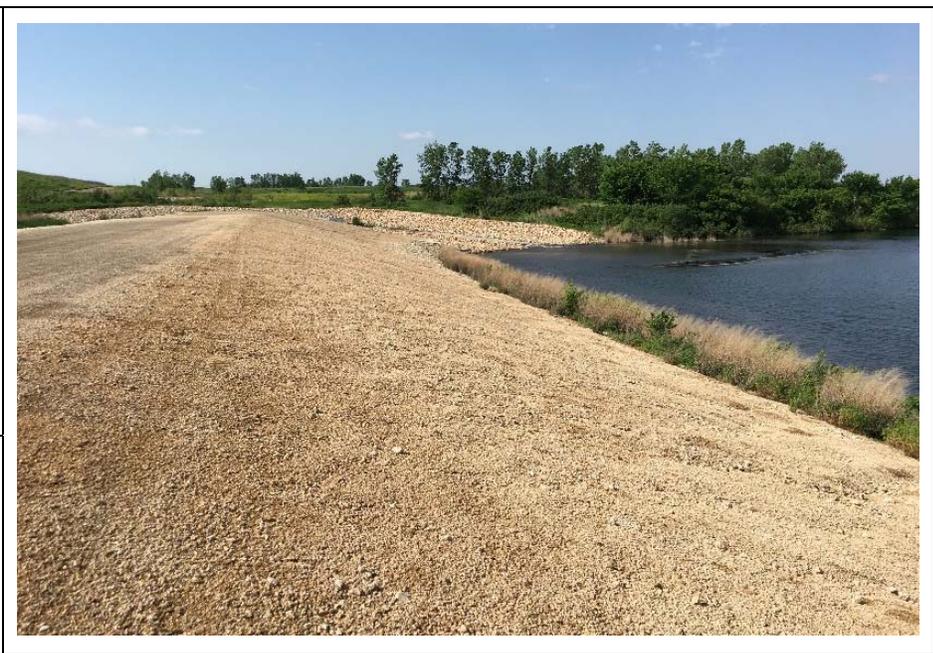
<p>Photograph No. 11</p> <p>Date: May 16, 2017</p> <p>Direction: Southwest</p>

<p>Description: Observing the downstream slope of the dam separating the Bottom Ash Pond and Tower Hill Lake. No erosion in this location.</p>

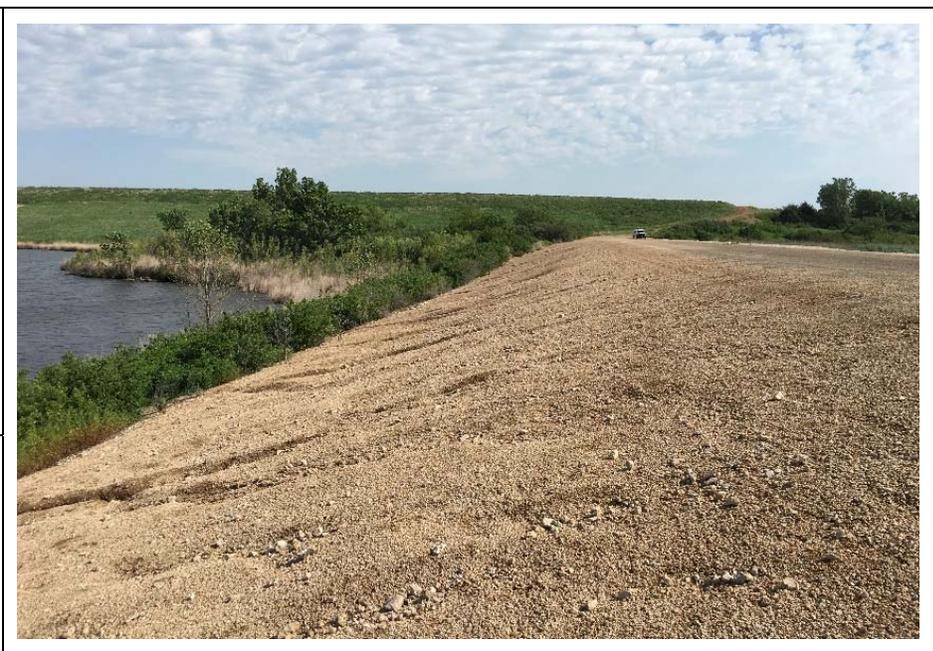
<p>Photograph No. 12</p> <p>Date: May 16, 2017</p> <p>Direction: Northeast</p>

<p>Description: Observing minor erosion of the dam separating the Bottom Ash Pond and Tower Hill Lake on the downstream slope. Established vegetation present.</p>

An inspection of the Pond was completed by APTIM personnel on May 16, 2017. During the 2017 annual inspection, slope appearance, slope stability, and overall site conditions were assessed. No erosion or sloughing was observed along the Surface Impoundment perimeter berm. At the time of inspection, stormwater conveyance systems such as the Pond stormwater drainage channels and the Pond Dam spillway were operating as designed. It was noted that erosion rills were observed on the Pond Dam's western side (downstream slope), which separates the Pond from Tower Hill Lake. This was consistent with the findings of the 2009 inspection. Photographs 12 through 15 in **Appendix A** depict the observed erosion rills on the downstream slope of the Pond Dam. Recommendations were provided to repair these rills and install rip-rap slope protection. The rills are intended to be repaired during the construction of the cap that is currently being completed. It was anticipated that the rills will be repaired as part of the final stages of construction of the cap and that the Pond Dam will remain stable until that moment. Once capping commences, the rills should be filled and regraded to remove preferential pathways for stormwater. After grading, rip-rap will be placed to minimize the potential for future erosion.

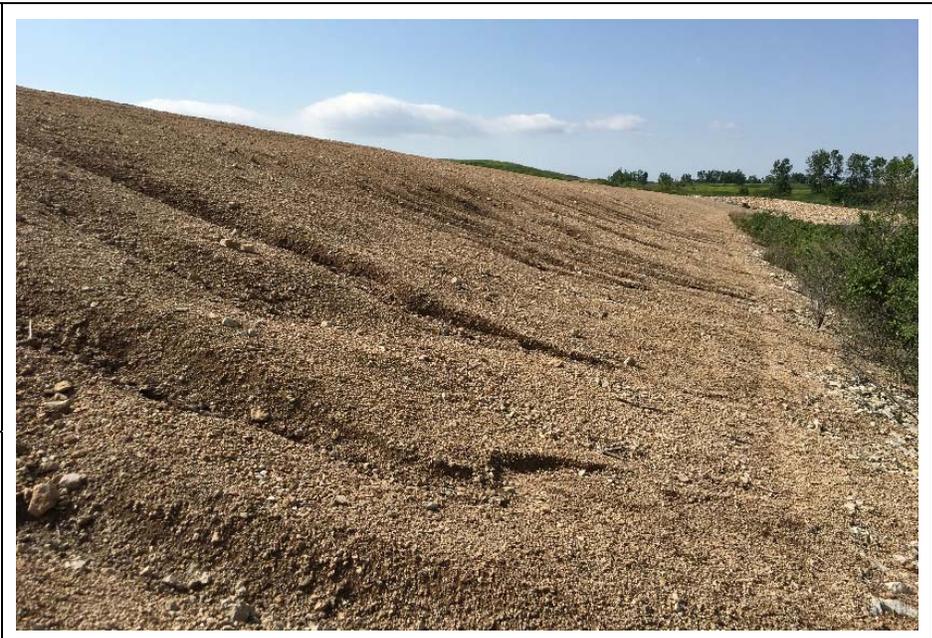
<p>Photograph No. 13</p> <p>Date: May 16, 2017</p> <p>Direction: South</p>

<p>Description: Observing erosion rills on the dam separating the Bottom Ash Pond and Tower Hill Lake on the downstream slope.</p>

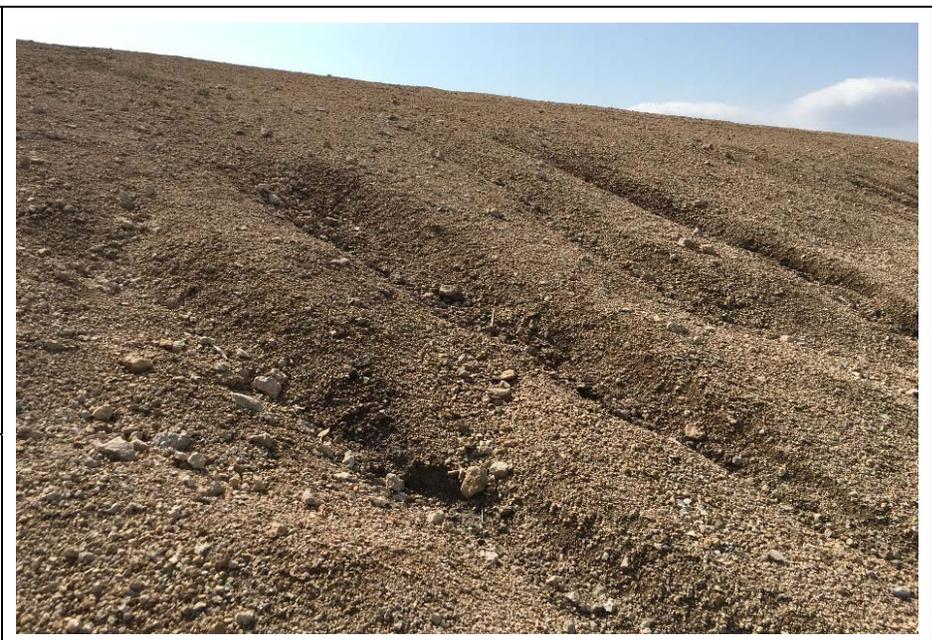
<p>Photograph No. 14</p> <p>Date: May 16, 2017</p> <p>Direction: Southeast</p>

<p>Description: Observing the erosion rills on the dam separating the Bottom Ash Pond and Tower Hill Lake on the downstream slope.</p>

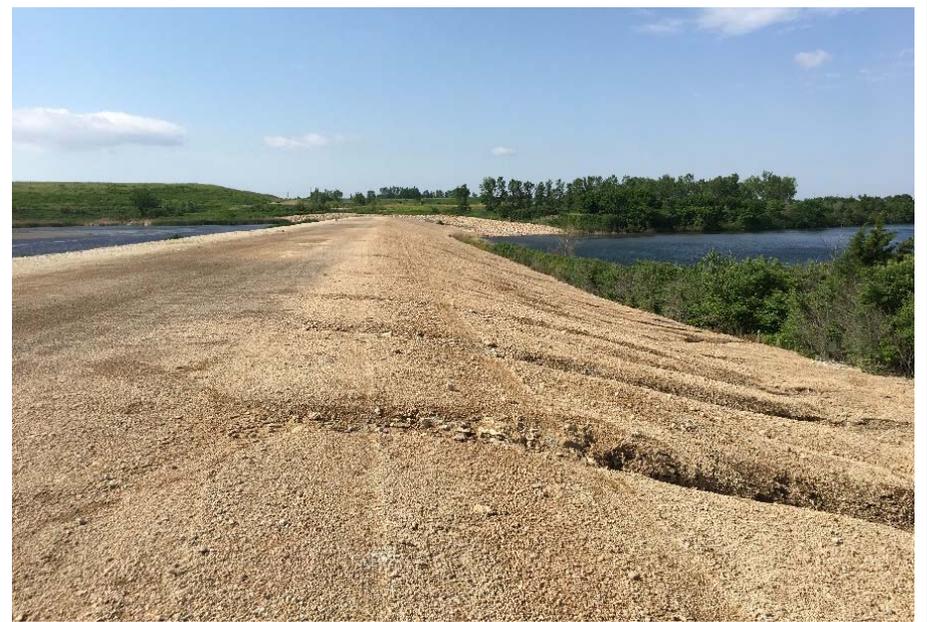
Photograph No. 15

Observing the dam that separates the Bottom Ash Pond from Tower Hill Lake. Erosion rills on downstream slope.

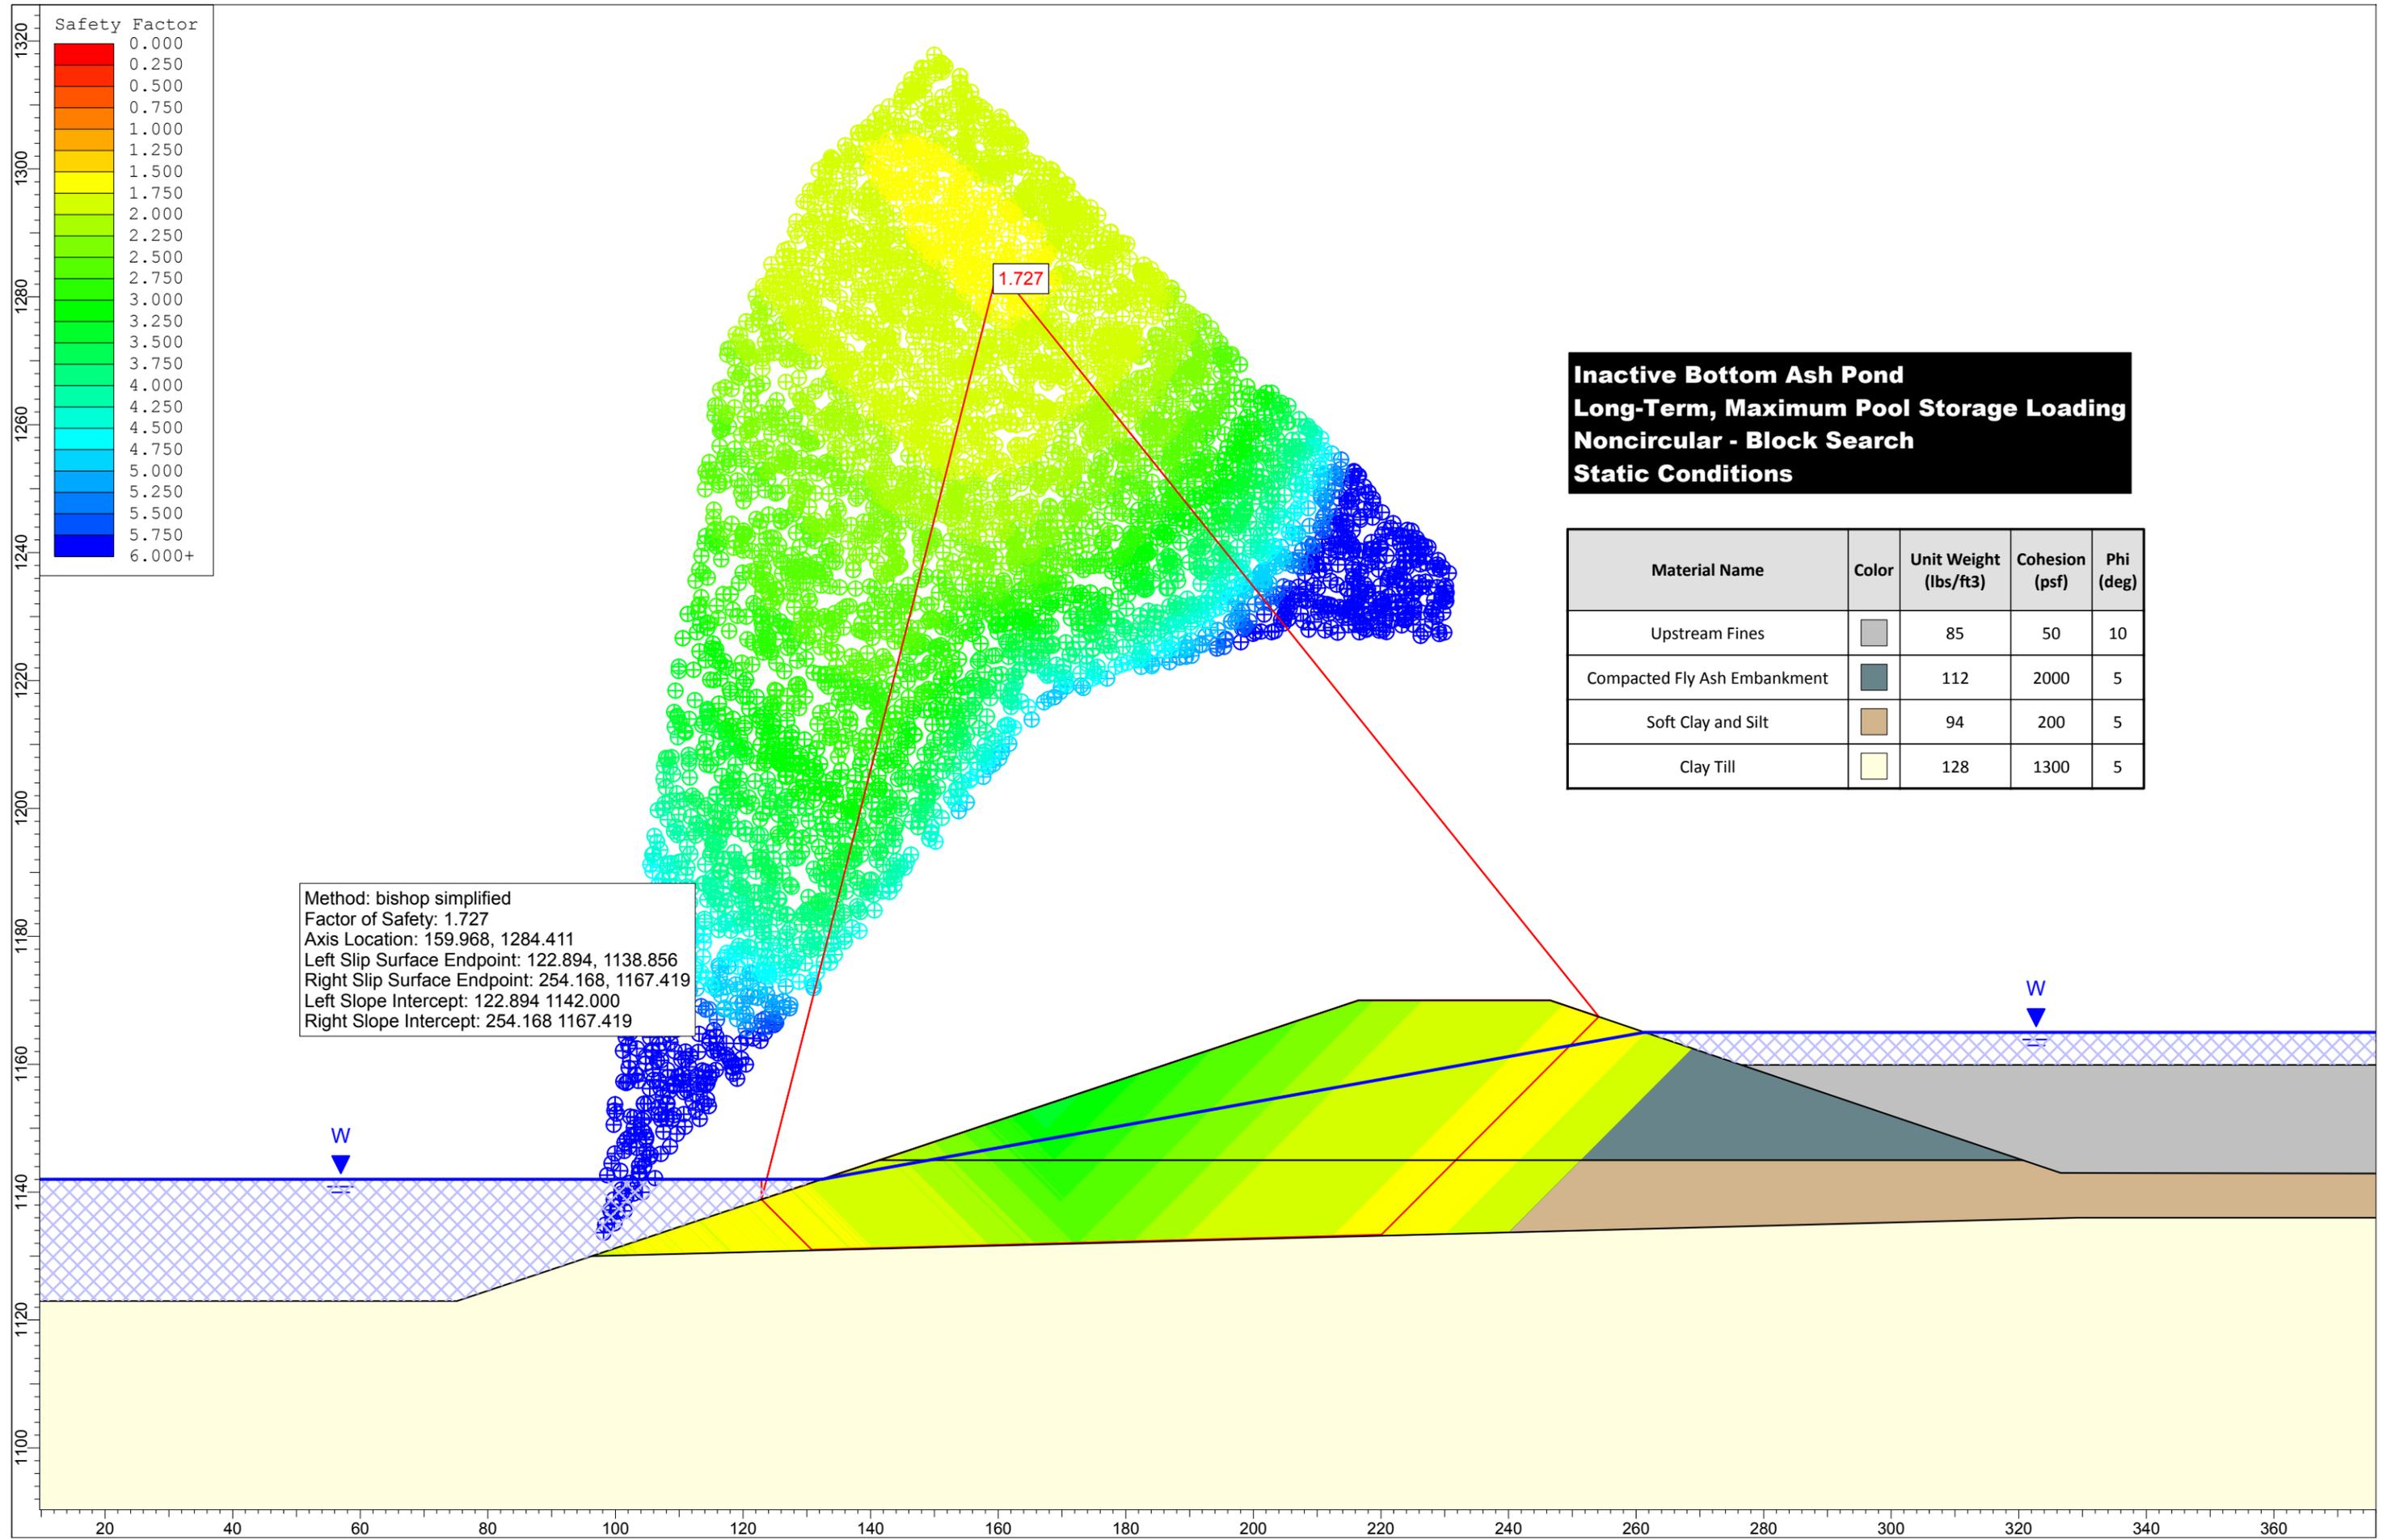
**Inactive Bottom Ash Pond
Long-Term, Maximum Pool Storage Loading
Noncircular - Block Search
Static Conditions**

Method: bishop simplified
 Factor of Safety: 1.727
 Axis Location: 159.968, 1284.411
 Left Slip Surface Endpoint: 122.894, 1138.856
 Right Slip Surface Endpoint: 254.168, 1167.419
 Left Slope Intercept: 122.894 1142.000
 Right Slope Intercept: 254.168 1167.419

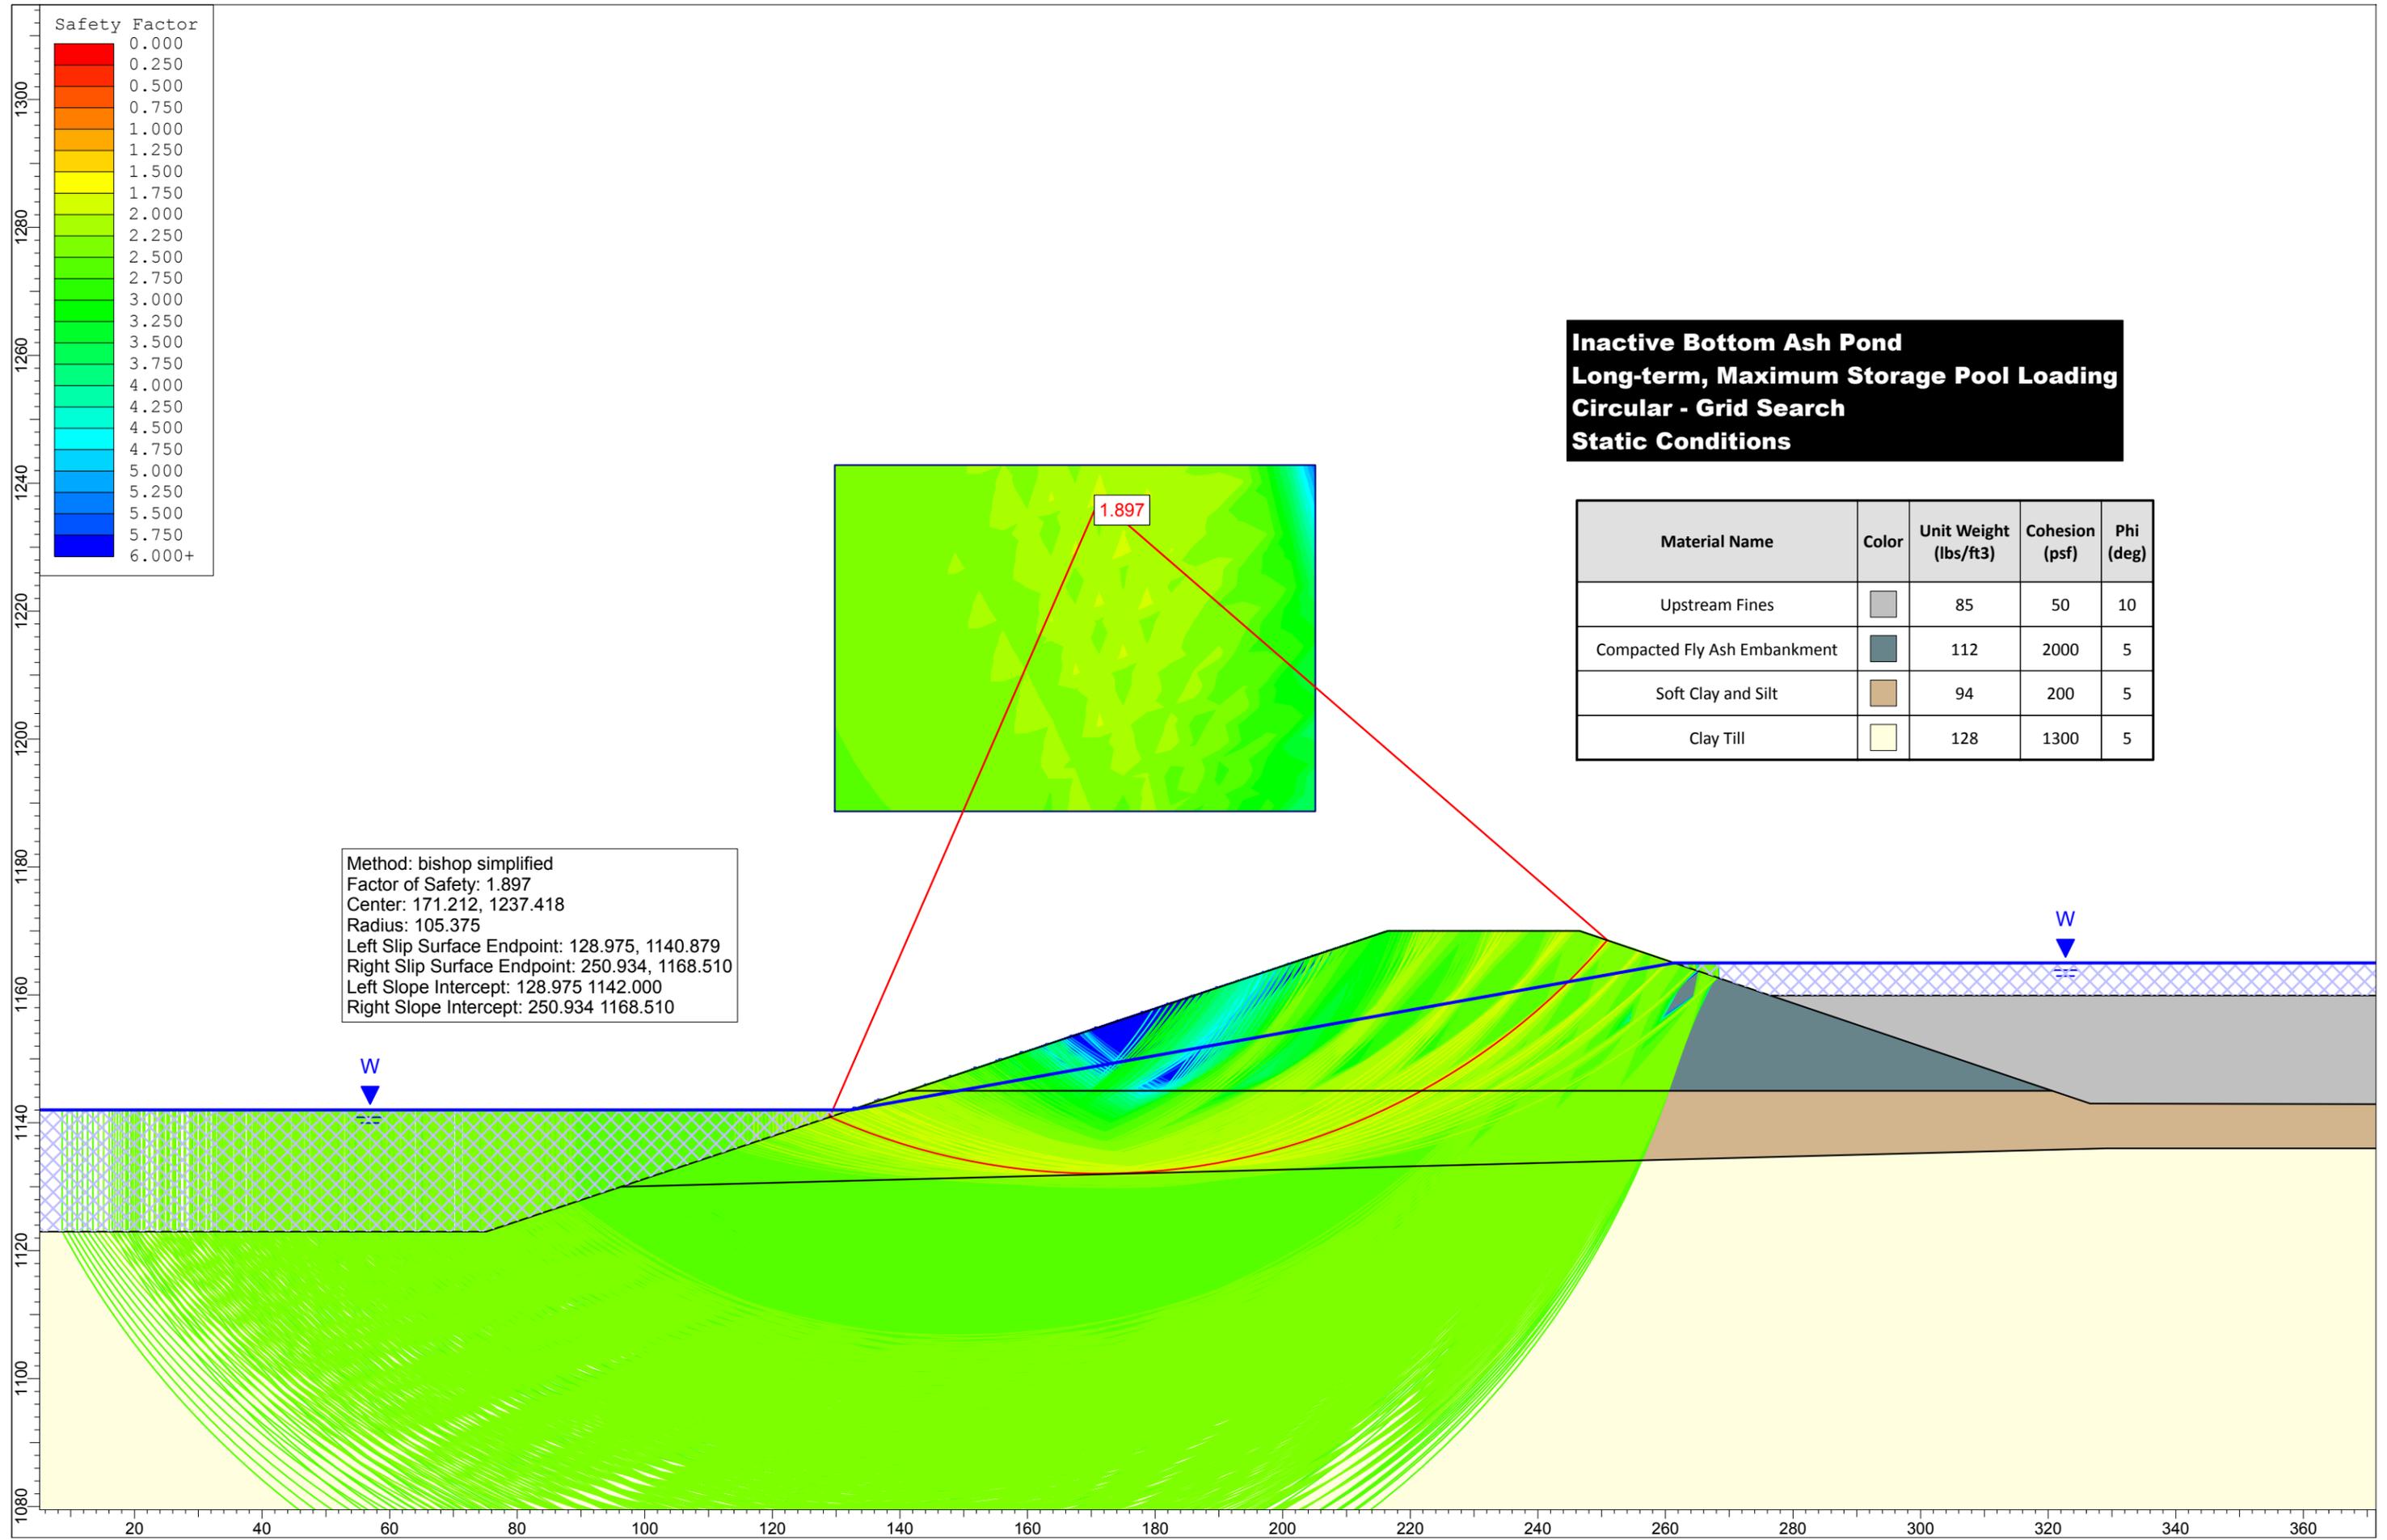
**Inactive Bottom Ash Pond
Long-term, Maximum Storage Pool Loading
Circular - Grid Search
Static Conditions**

Method: bishop simplified
 Factor of Safety: 1.897
 Center: 171.212, 1237.418
 Radius: 105.375
 Left Slip Surface Endpoint: 128.975, 1140.879
 Right Slip Surface Endpoint: 250.934, 1168.510
 Left Slope Intercept: 128.975 1142.000
 Right Slope Intercept: 250.934 1168.510

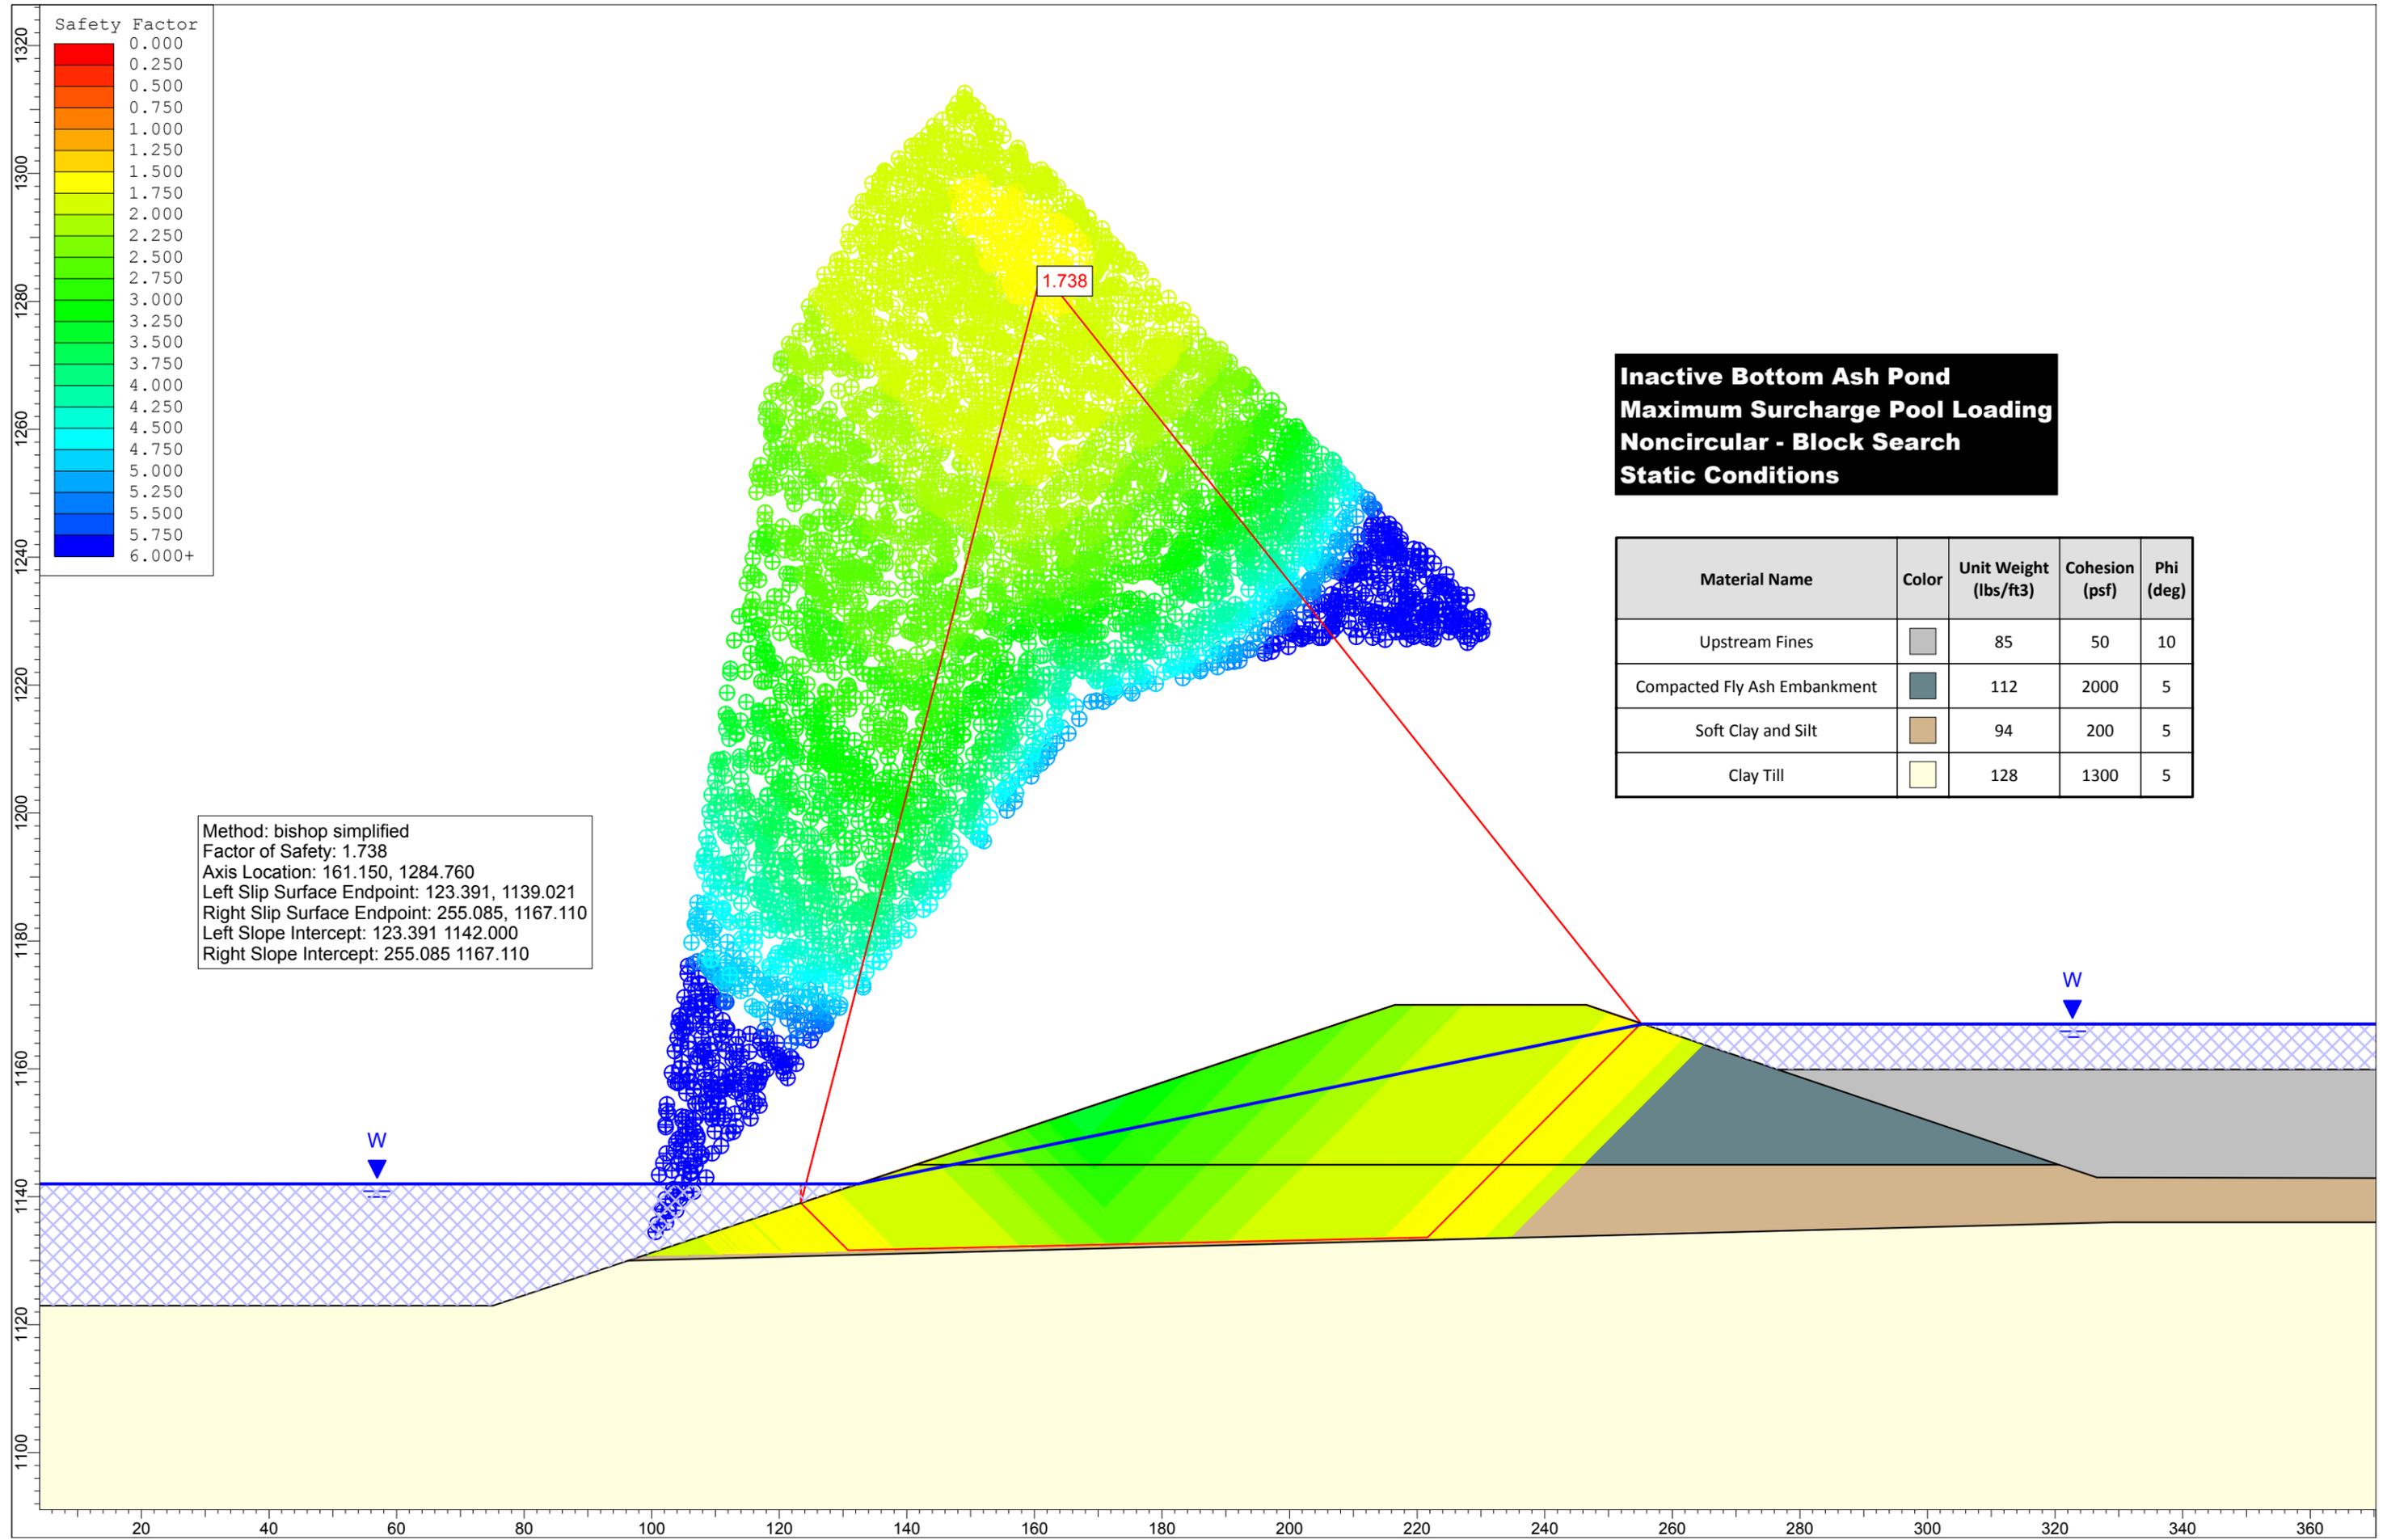
**Inactive Bottom Ash Pond
Maximum Surcharge Pool Loading
Noncircular - Block Search
Static Conditions**

The calculated static factor of safety is 1.738 for the Pond Dam and meets the requirement for the maximum surcharge pool condition (1.40), per §257.73(e)(1)(ii).

Method: bishop simplified
 Factor of Safety: 1.738
 Axis Location: 161.150, 1284.760
 Left Slip Surface Endpoint: 123.391, 1139.021
 Right Slip Surface Endpoint: 255.085, 1167.110
 Left Slope Intercept: 123.391 1142.000
 Right Slope Intercept: 255.085 1167.110
