Initial Safety Factor Assessment Jeffrey Energy Center Inactive Bottom Ash Pond

Prepared for:
Westar Energy
Jeffrey Energy Center
St. Marys, Kansas

Prepared by:
APTIM Environmental & Infrastructure, Inc.

April 2018

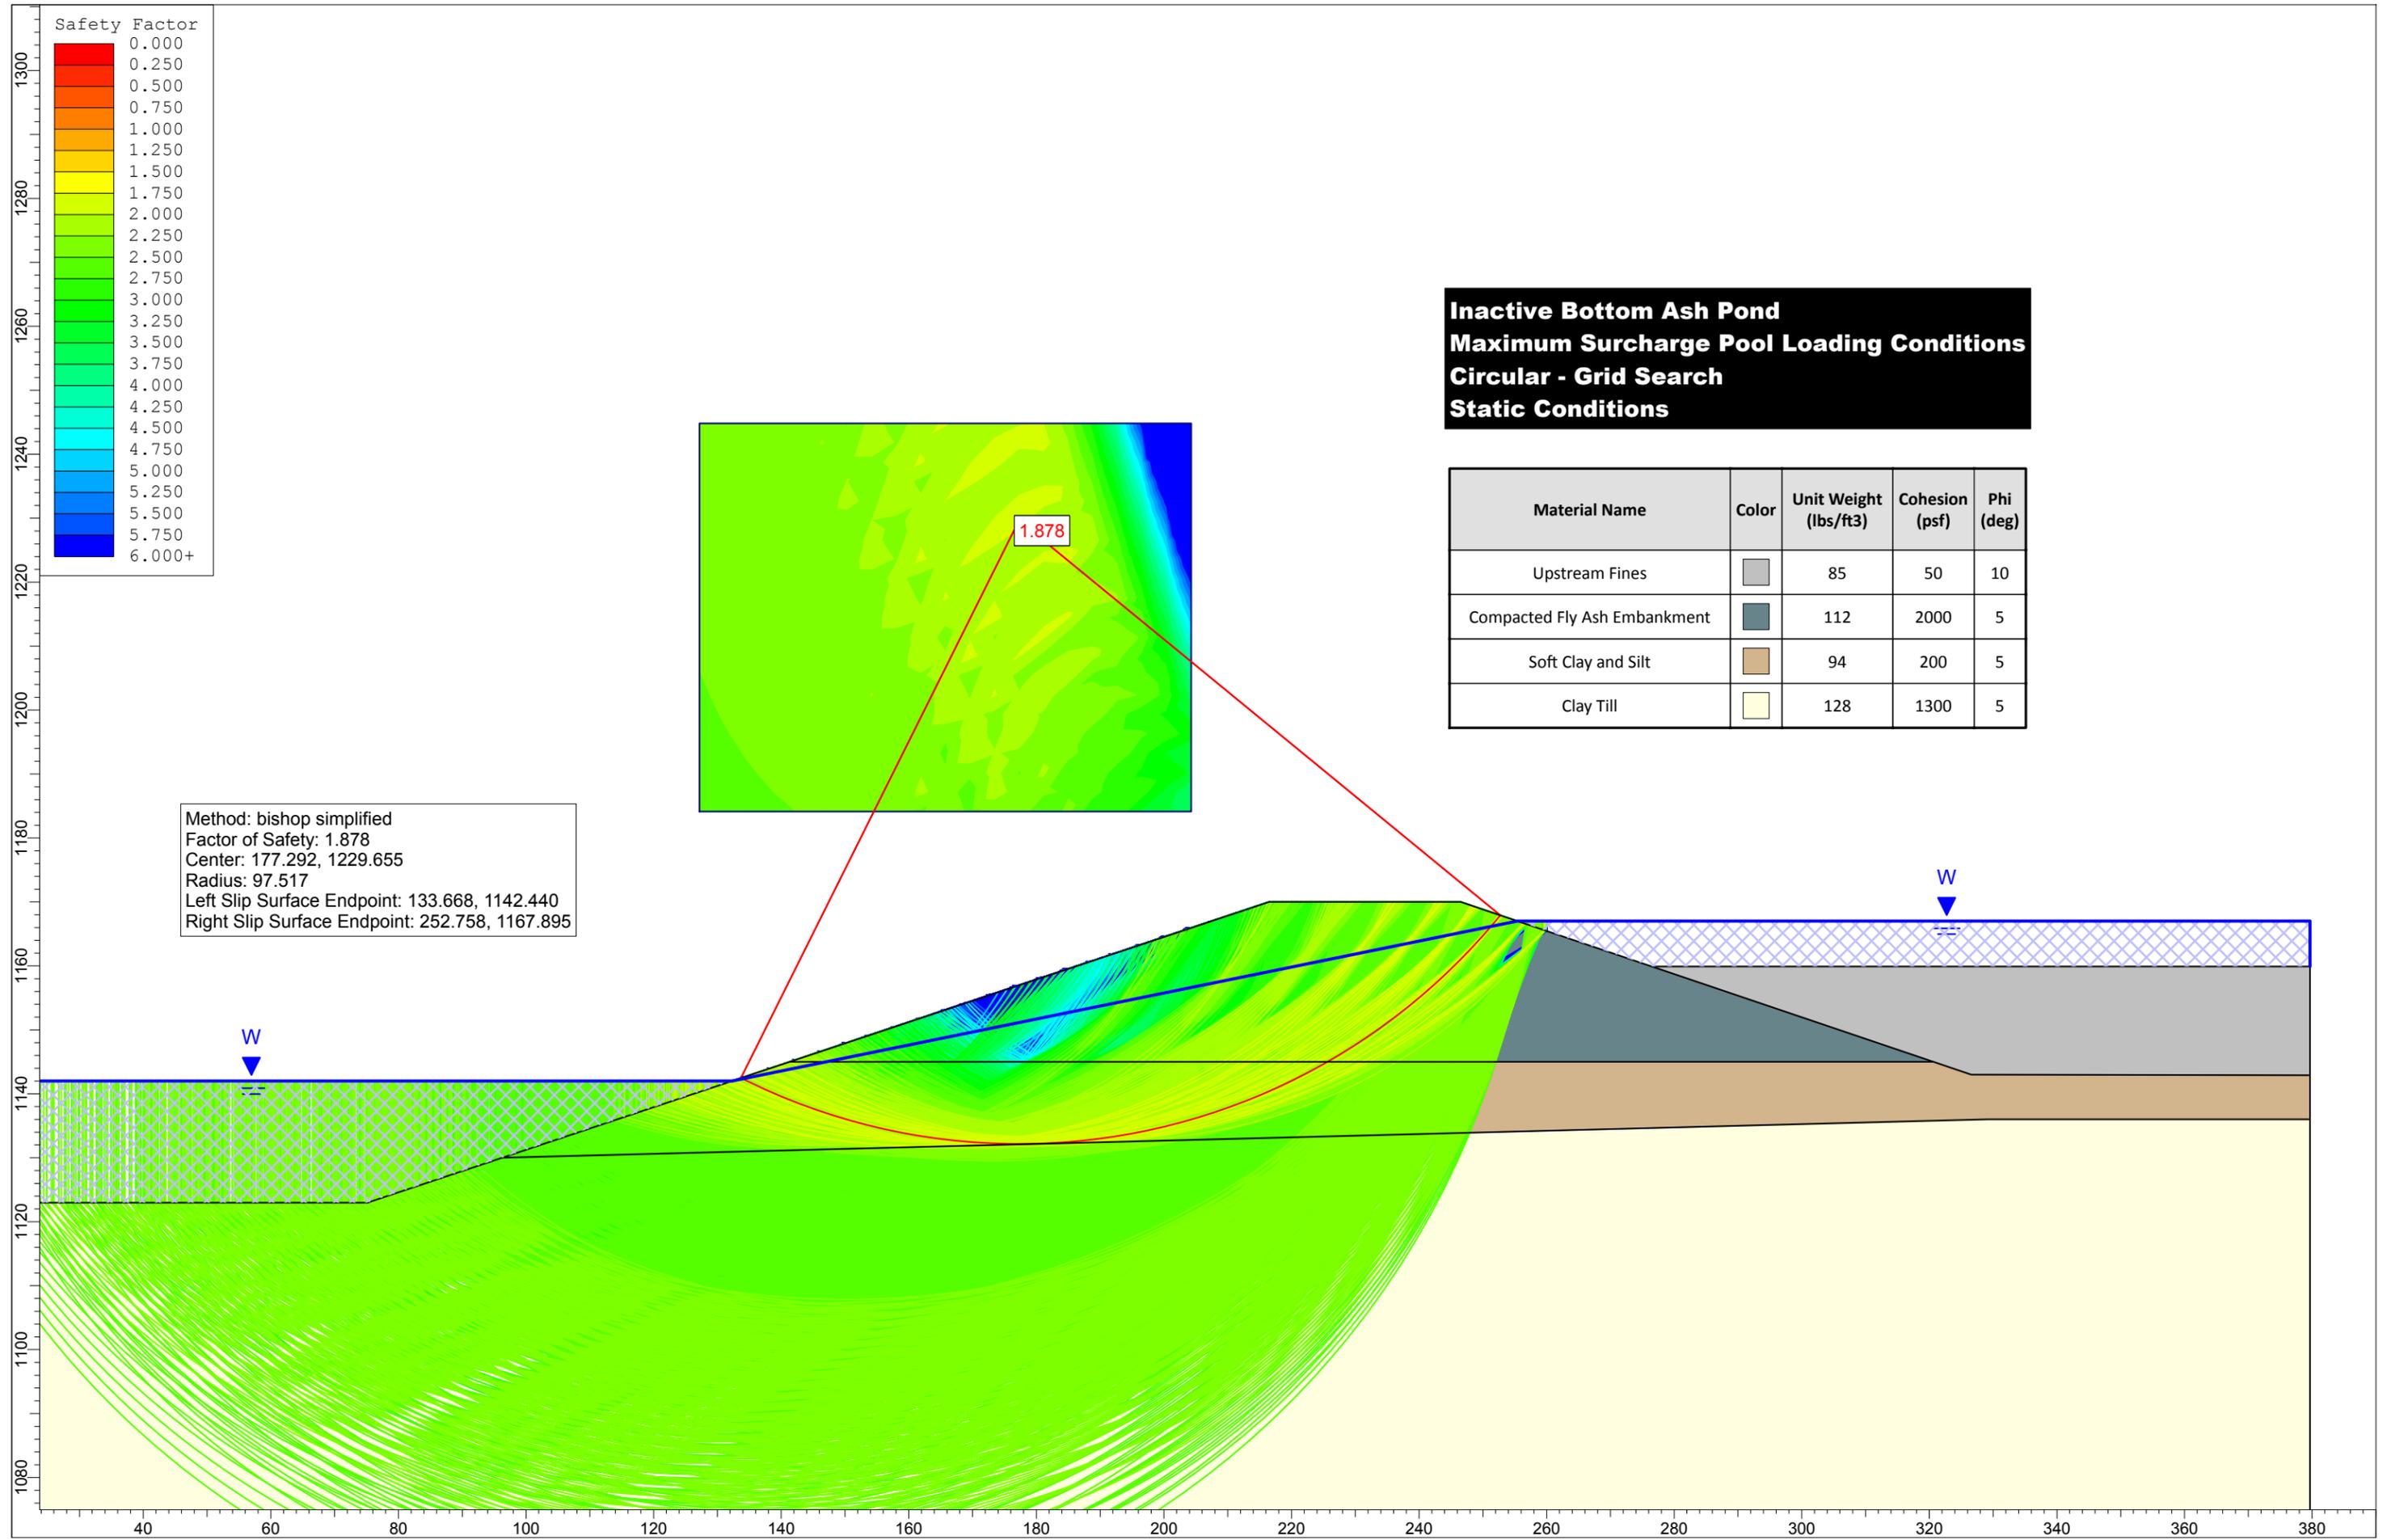
**Inactive Bottom Ash Pond
 Maximum Surcharge Pool Loading Conditions
 Circular - Grid Search
 Static Conditions**

Method: bishop simplified
 Factor of Safety: 1.878
 Center: 177.292, 1229.655
 Radius: 97.517
 Left Slip Surface Endpoint: 133.668, 1142.440
 Right Slip Surface Endpoint: 252.758, 1167.895

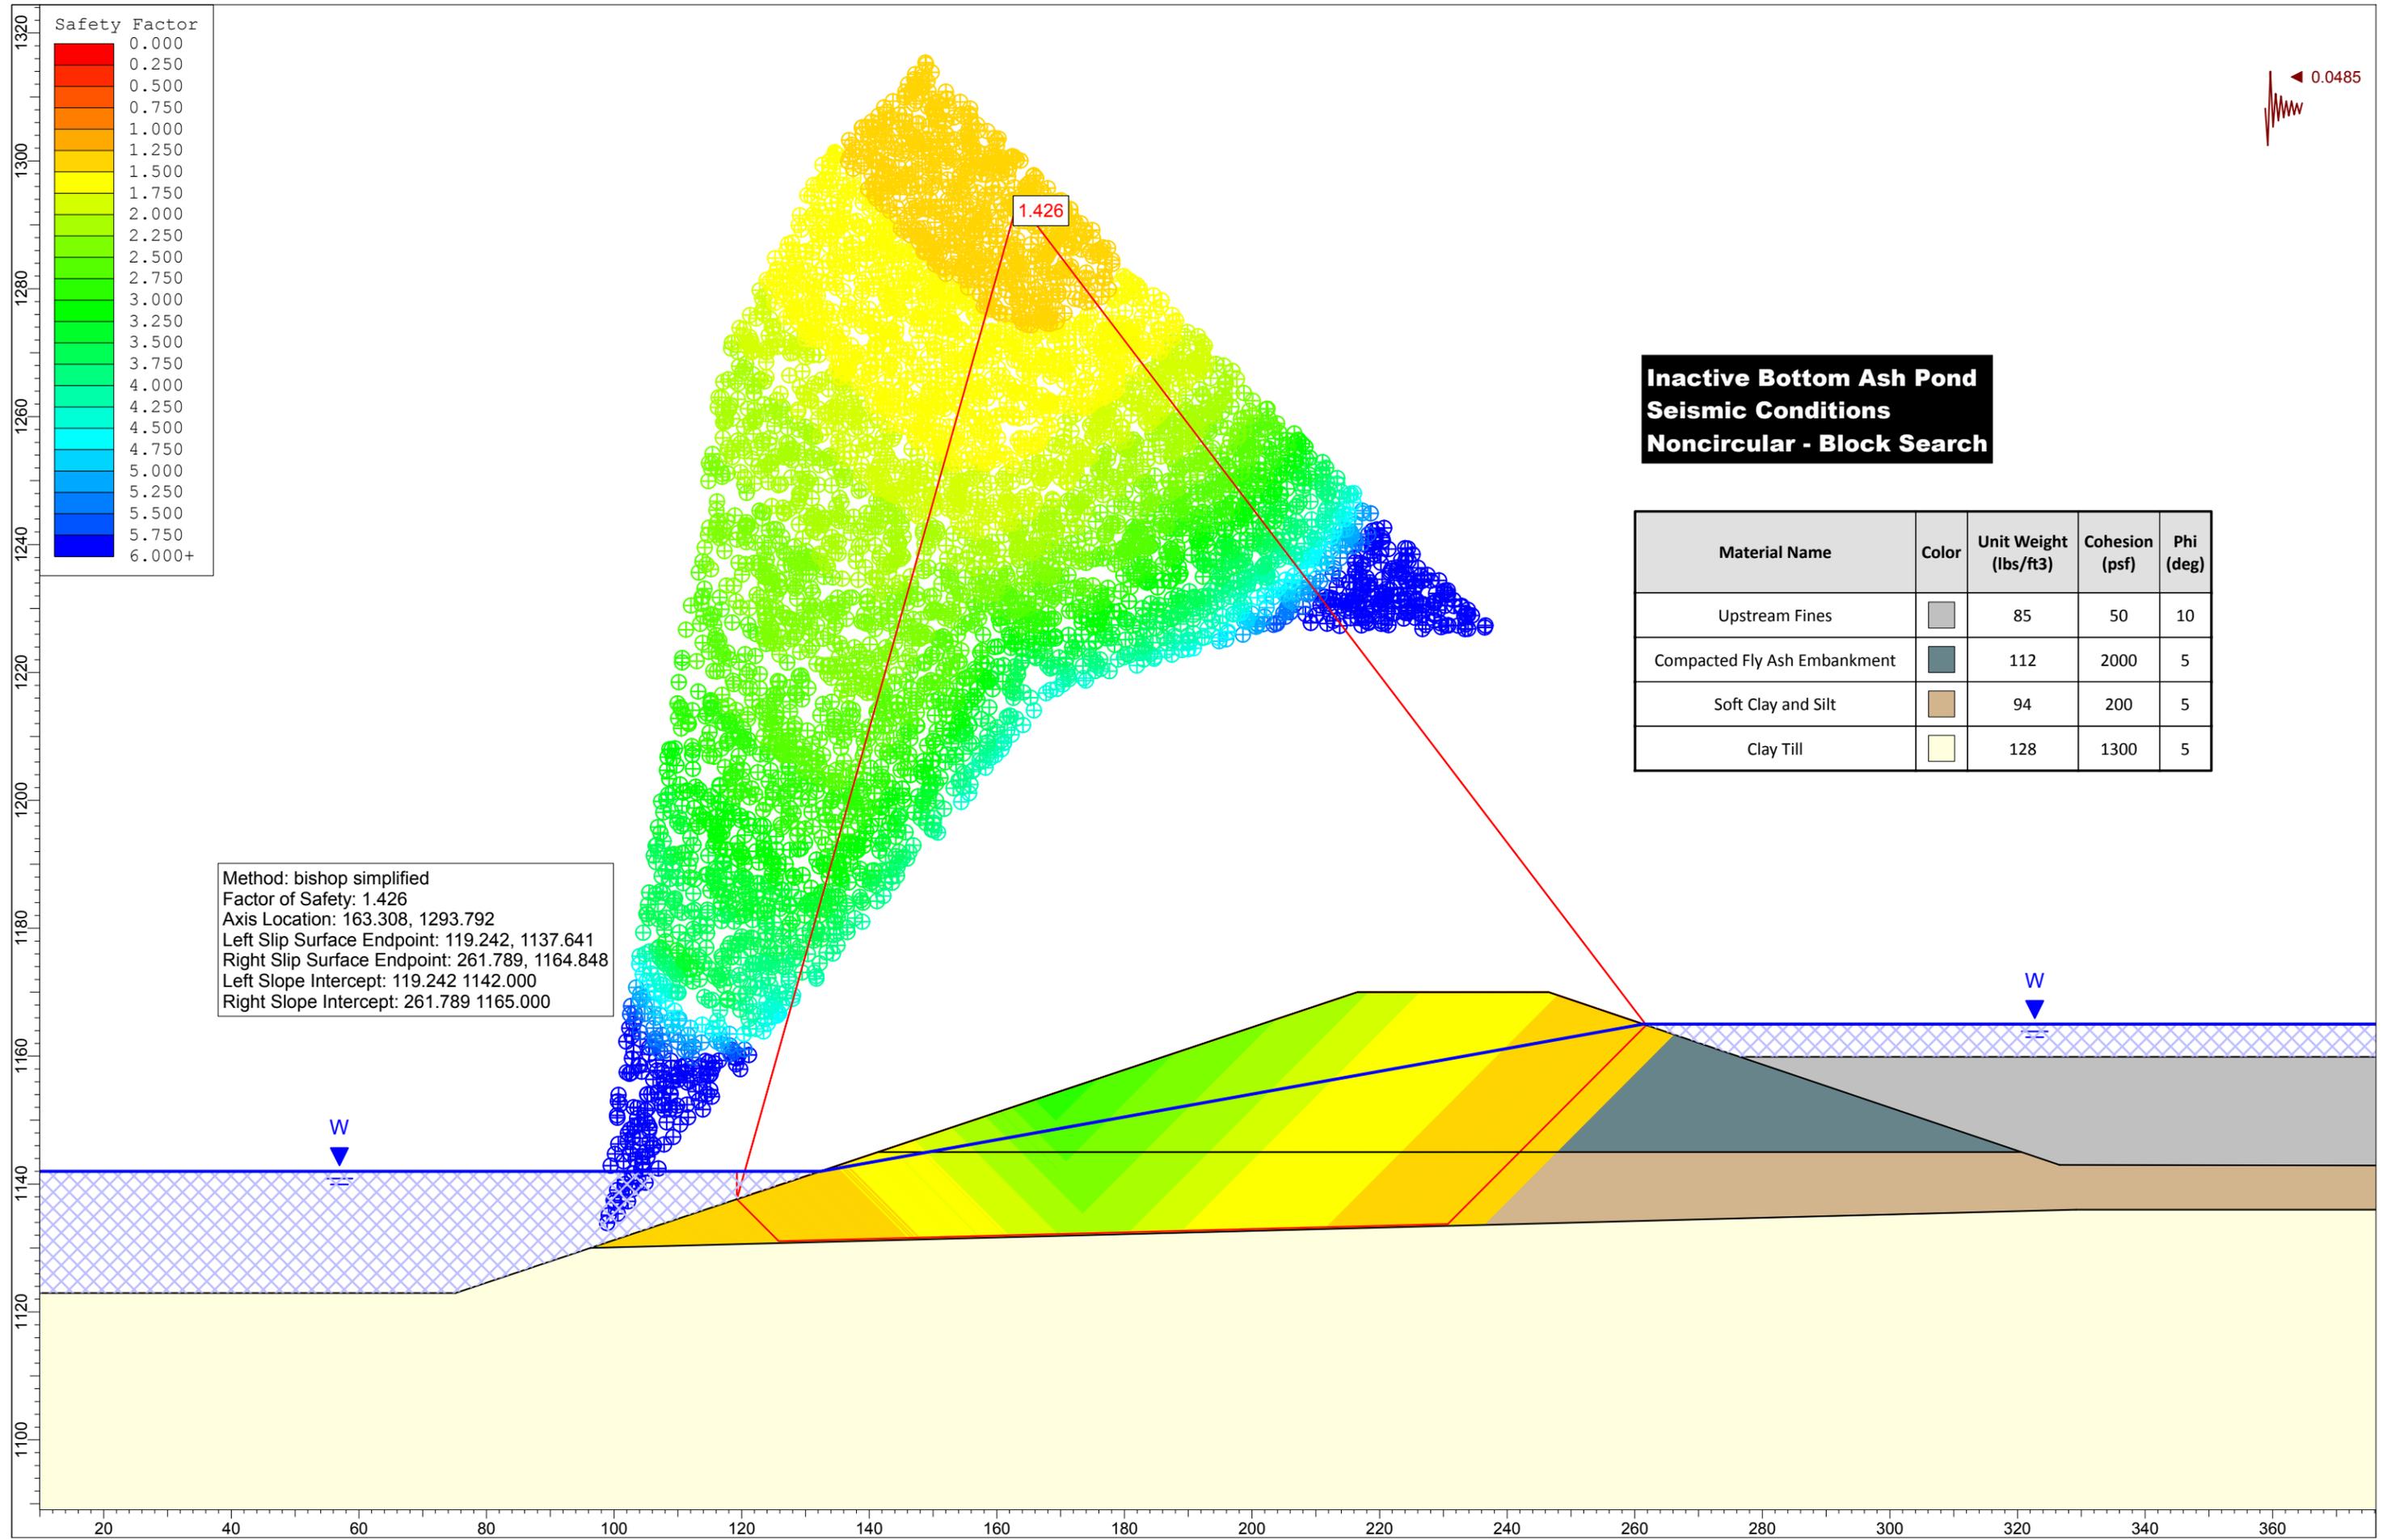
**Inactive Bottom Ash Pond
Seismic Conditions
Noncircular - Block Search**

Method: bishop simplified
 Factor of Safety: 1.426
 Axis Location: 163.308, 1293.792
 Left Slip Surface Endpoint: 119.242, 1137.641
 Right Slip Surface Endpoint: 261.789, 1164.848
 Left Slope Intercept: 119.242 1142.000
 Right Slope Intercept: 261.789 1165.000

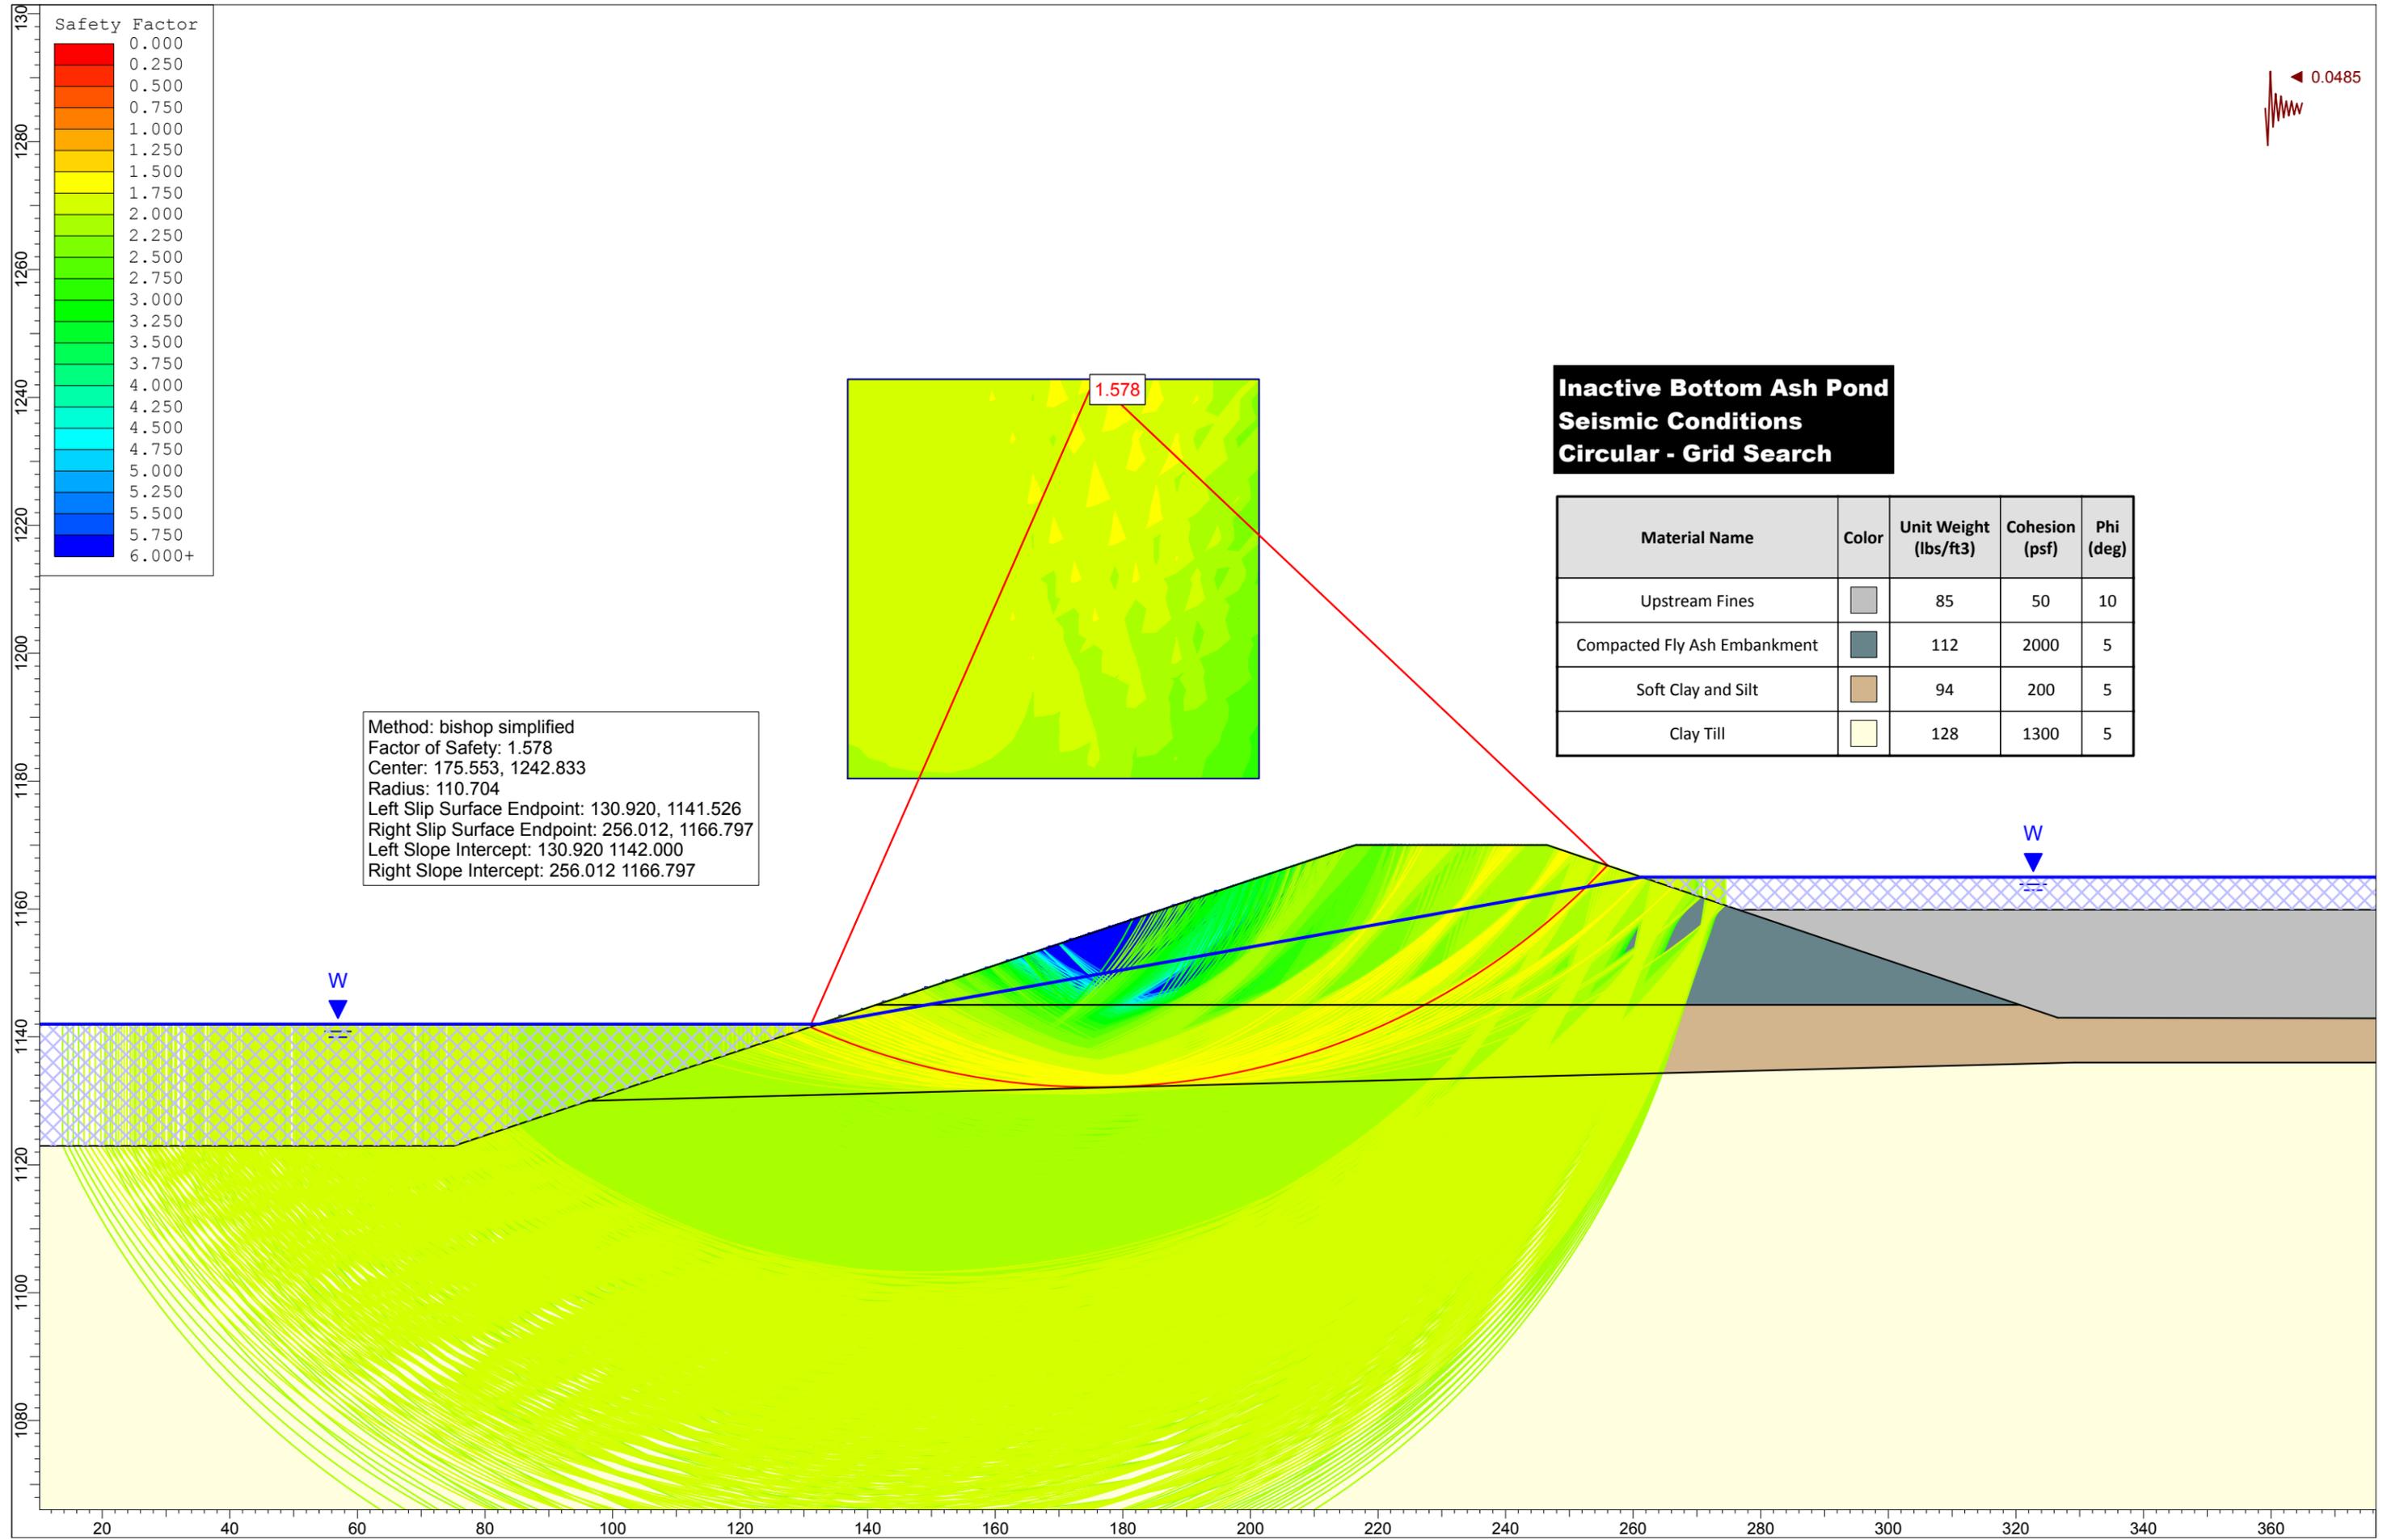
**Inactive Bottom Ash Pond
 Seismic Conditions
 Circular - Grid Search**

Method: bishop simplified
 Factor of Safety: 1.578
 Center: 175.553, 1242.833
 Radius: 110.704
 Left Slip Surface Endpoint: 130.920, 1141.526
 Right Slip Surface Endpoint: 256.012, 1166.797
 Left Slope Intercept: 130.920 1142.000
 Right Slope Intercept: 256.012 1166.797

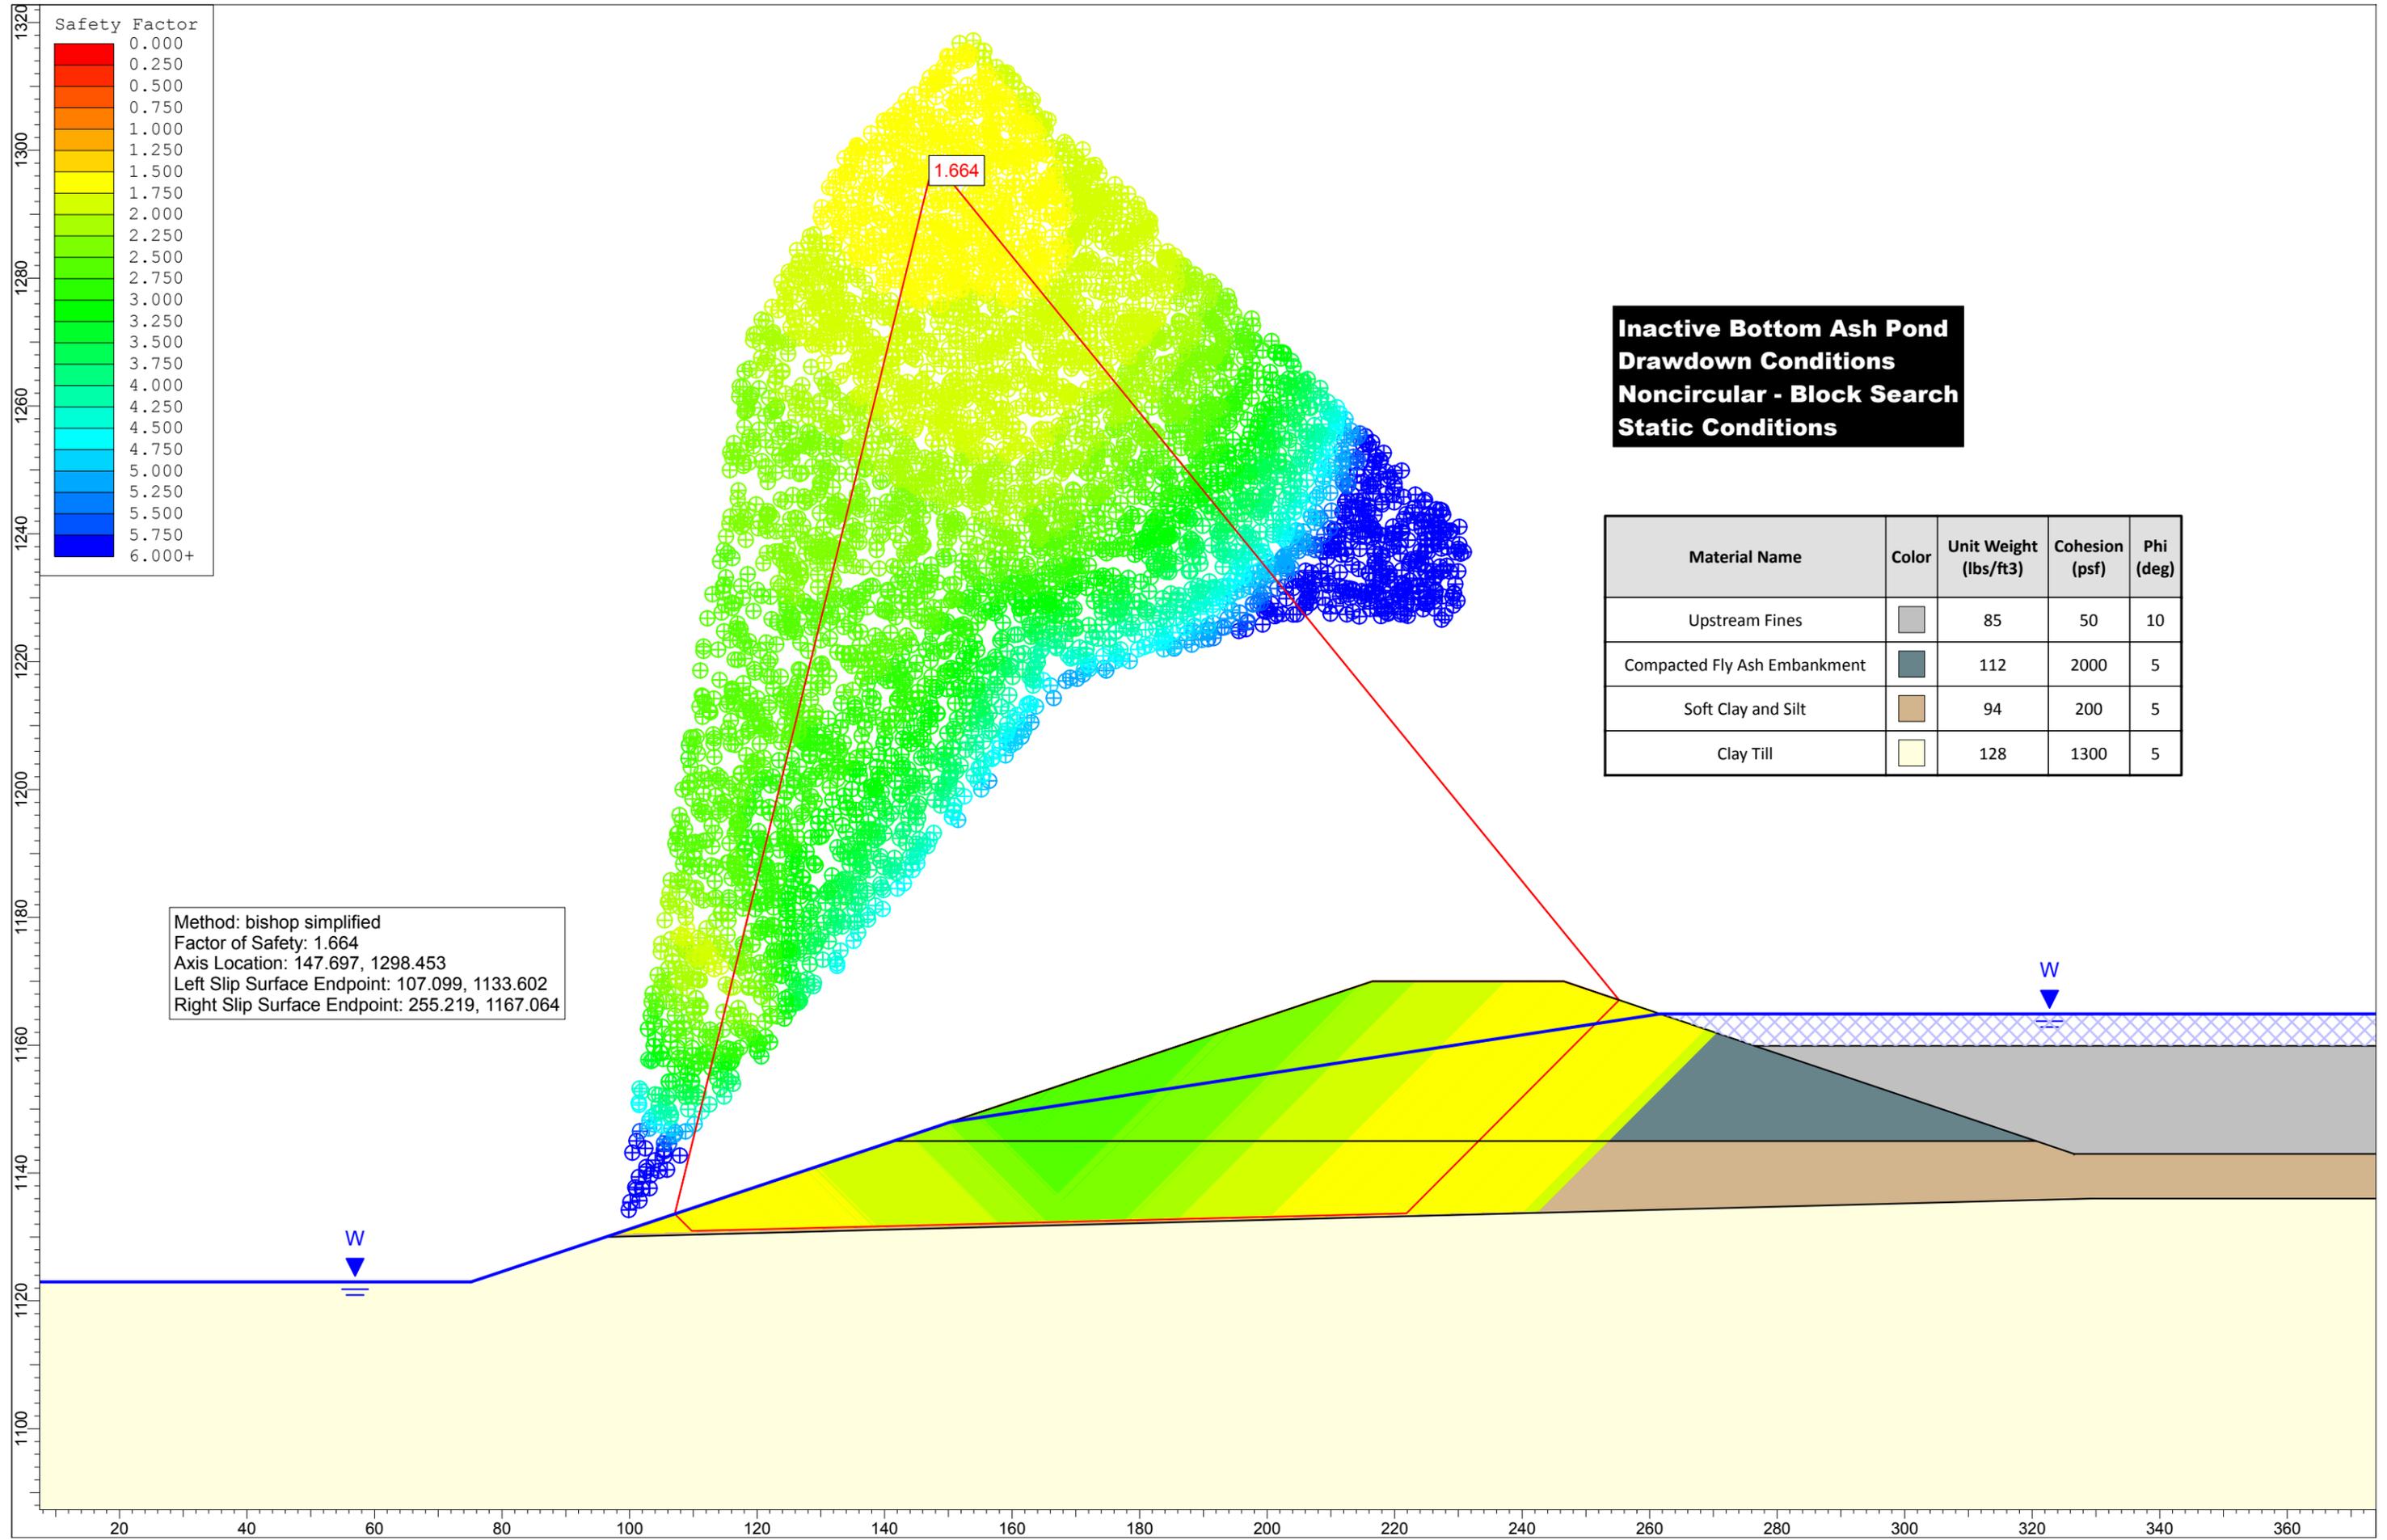
**Inactive Bottom Ash Pond
Drawdown Conditions
Noncircular - Block Search
Static Conditions**

40 CFR §257.73 does not require that drawdown conditions are modeled. However for CCR units with downstream slopes which can be inundated by the pool of an adjacent water body (i.e. Tower Hill Lake) it is required that the slopes that will maintain structural integrity in events of drawdown of the adjacent water body. Therefore, a drawdown scenario was created where the stabilizing force of the water from Tower Hill Lake is removed and the Pond is operating at maximum water level (1,165 ft MSL). The calculated static factor of safety is 1.664 for the Pond Dam, which is determined to be acceptable by industry standards.

Method: bishop simplified
 Factor of Safety: 1.664
 Axis Location: 147.697, 1298.453
 Left Slip Surface Endpoint: 107.099, 1133.602
 Right Slip Surface Endpoint: 255.219, 1167.064
