Location Restrictions Demonstration Report - Wetlands, Fault Areas, Seismic Impact Zone and Unstable Areas

Bottom Ash Settling Area

Jeffrey Energy Center

Prepared for: Westar Energy
Jeffrey Energy Center
St. Marys, Kansas

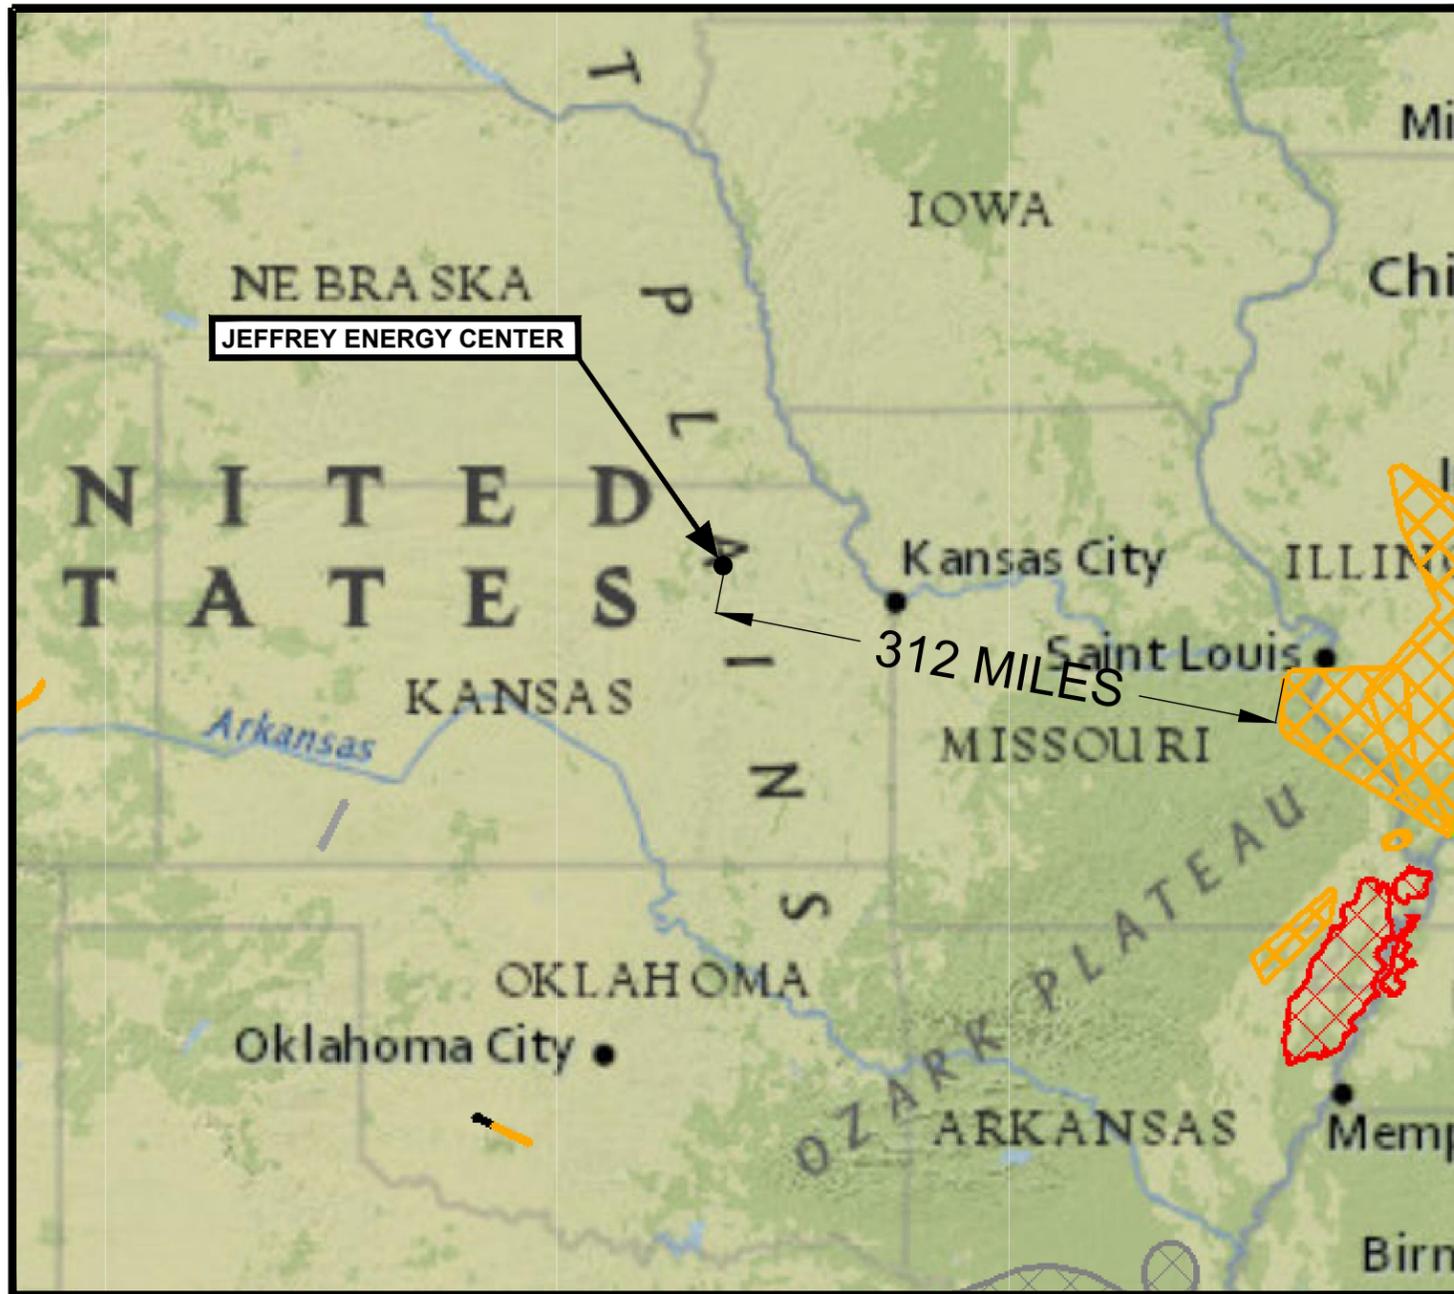
FIGURE 3
MAP OF FAULT AREAS

APTIM compared the location of the Unit to the location of faults from the Holocene time, as shown in the United States Geologic Survey (USGS) Quaternary Fault and Fold Database for the United States. The nearest fault area is indicated on **Figure 3**. Based on this review, APTIM determined the Unit is not located within 200 feet of the outermost damage zone of a fault that has had displacement in the Holocene time. Consequently, no additional demonstration is necessary.

USGS QUATERNARY FAULTS AND FOLDS DATABASE
