Initial Safety Factor Assessment Jeffrey Energy Center Inactive Bottom Ash Pond

Prepared for:
Westar Energy
Jeffrey Energy Center
St. Marys, Kansas

Prepared by:
APTIM Environmental & Infrastructure, Inc.

April 2018

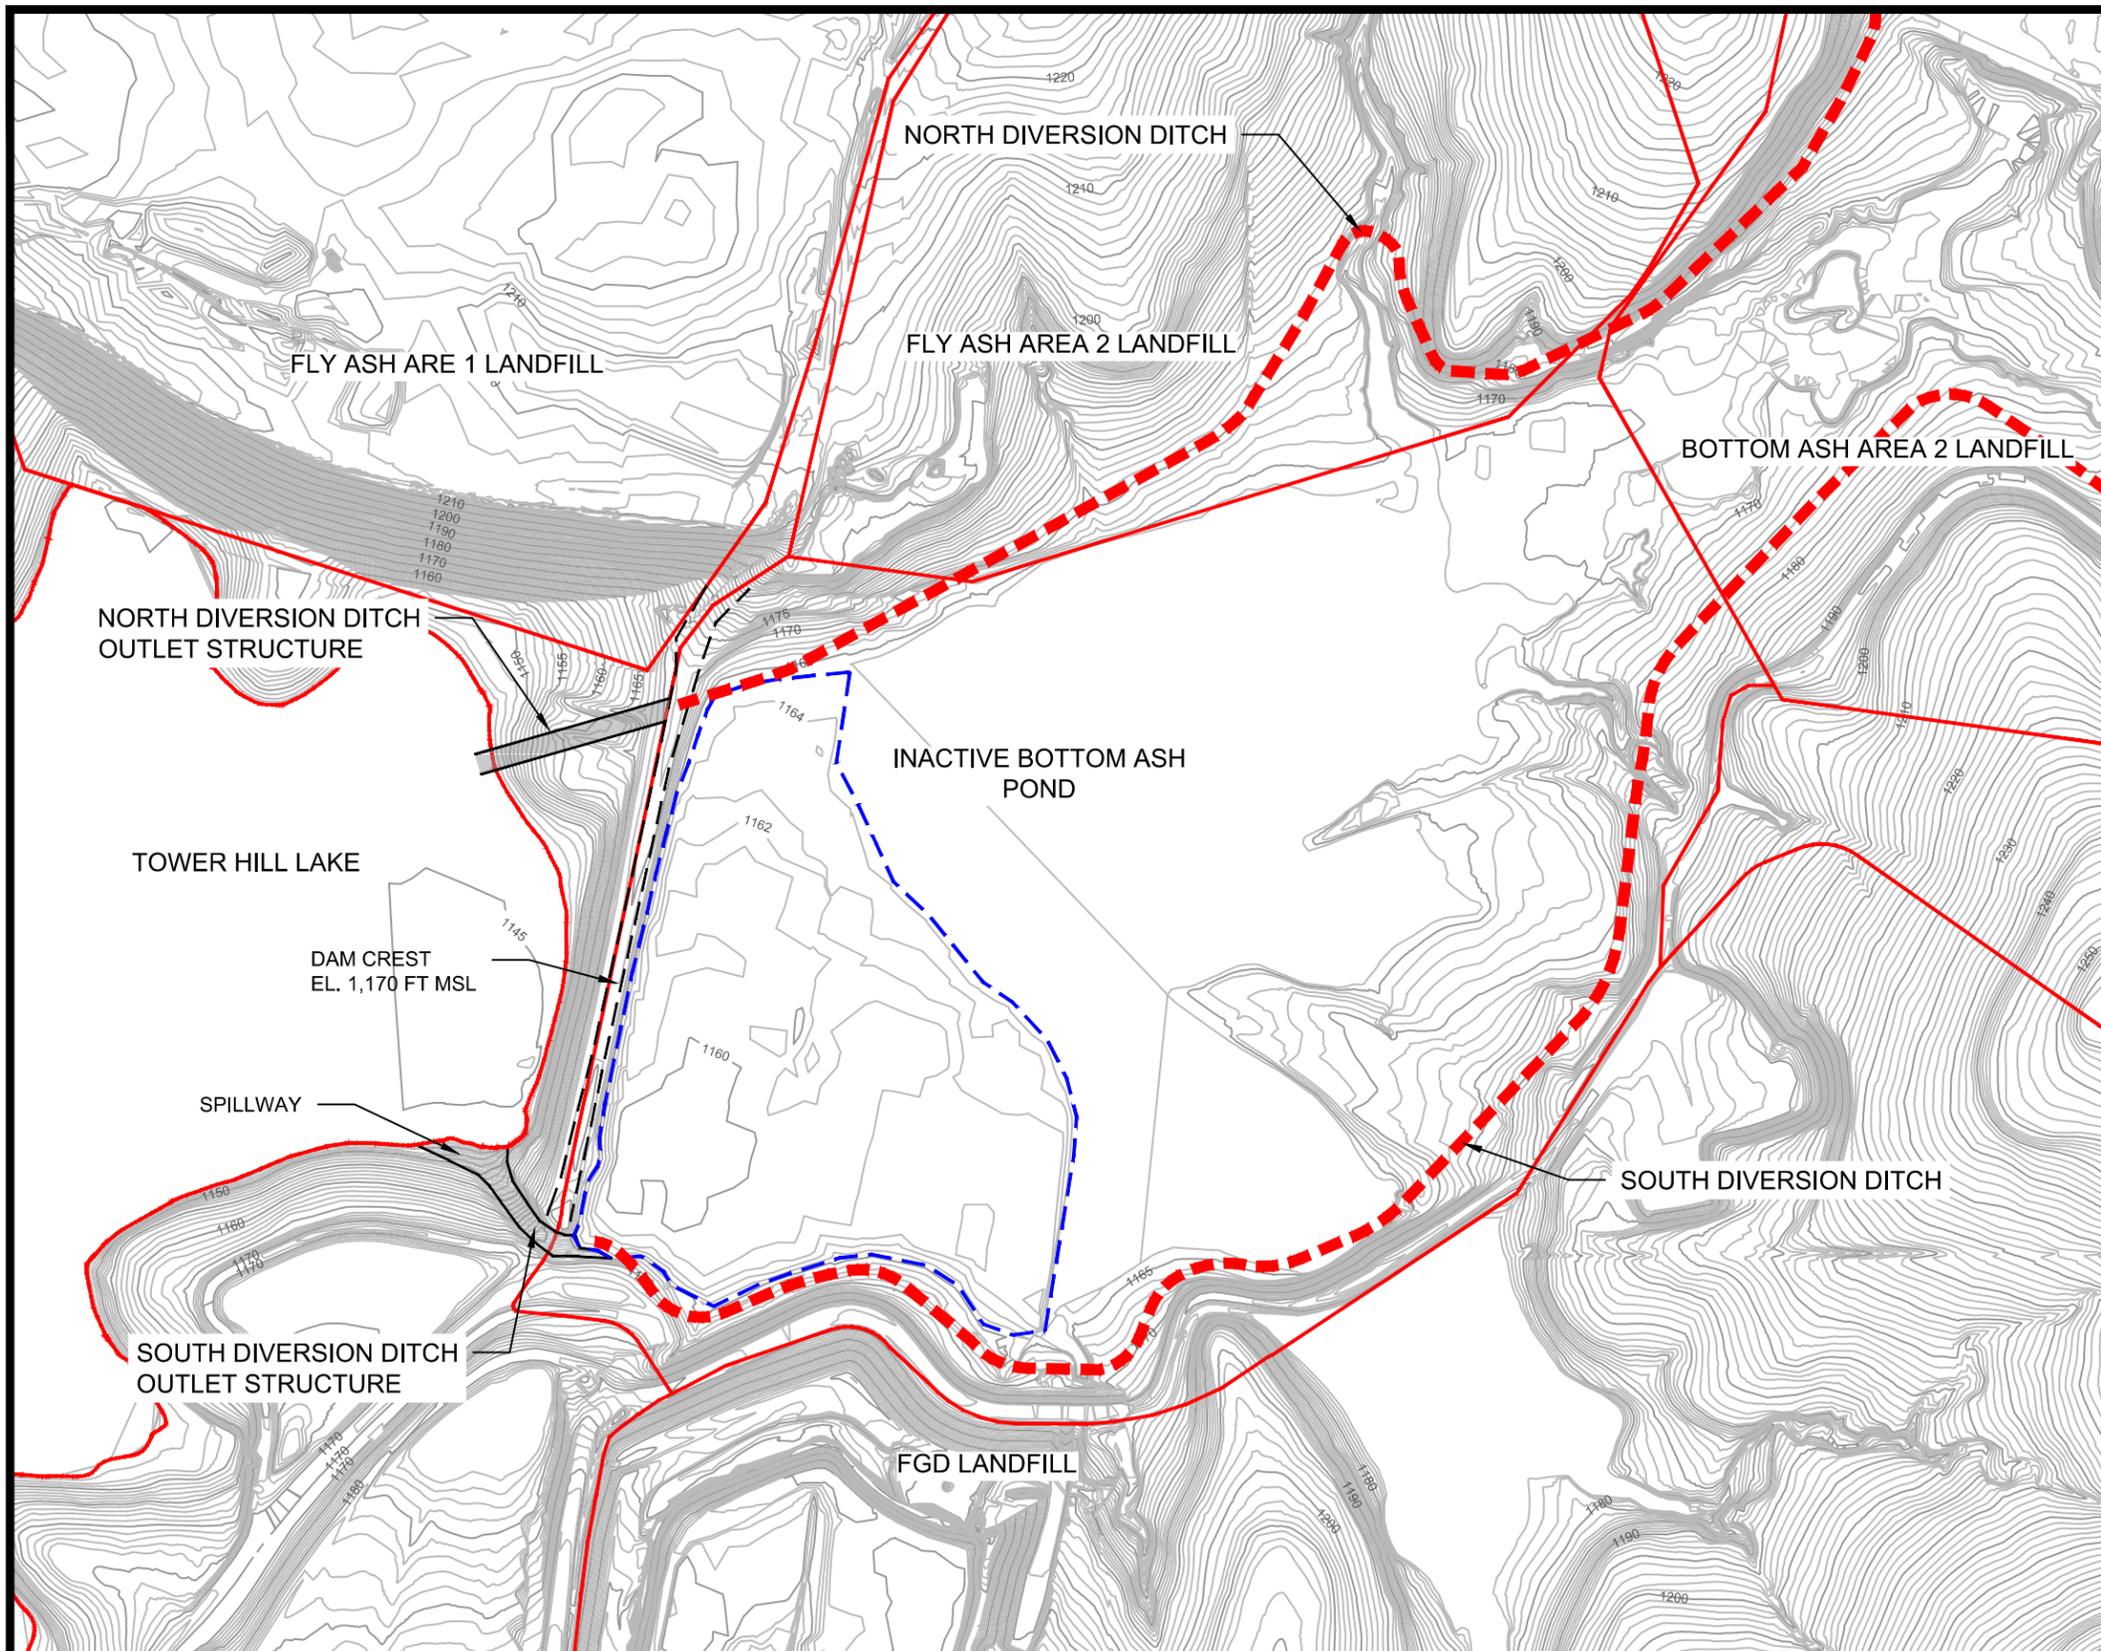
FIGURE 2
INACTIVE BOTTOM ASH POND
SITE TOPOGRAPHY PRIOR TO CLOSURE

The Pond is currently undergoing closure and has been dewatered. Historically, the typical impounded water volume within the Pond was determined to be approximately 62,680 cubic yards (cy), as described in the 2017 Annual Inspection Report. The CCR depths within the Pond have varied through time due to the continual deposit and discharge of water and CCR materials, and whether the fines have settled out in the alluvial fan/ravine (elevation higher than 1,164 ft MSL). The remaining CCR material storage capacity within the Pond was calculated in the 2017 Annual Inspection Report and was determined to be approximately 138,232 cy. The total CCR volume is unknown due to a range of ash material sources historically being routed to the Pond. Site topography prior to closure is depicted in **Figure 2**.

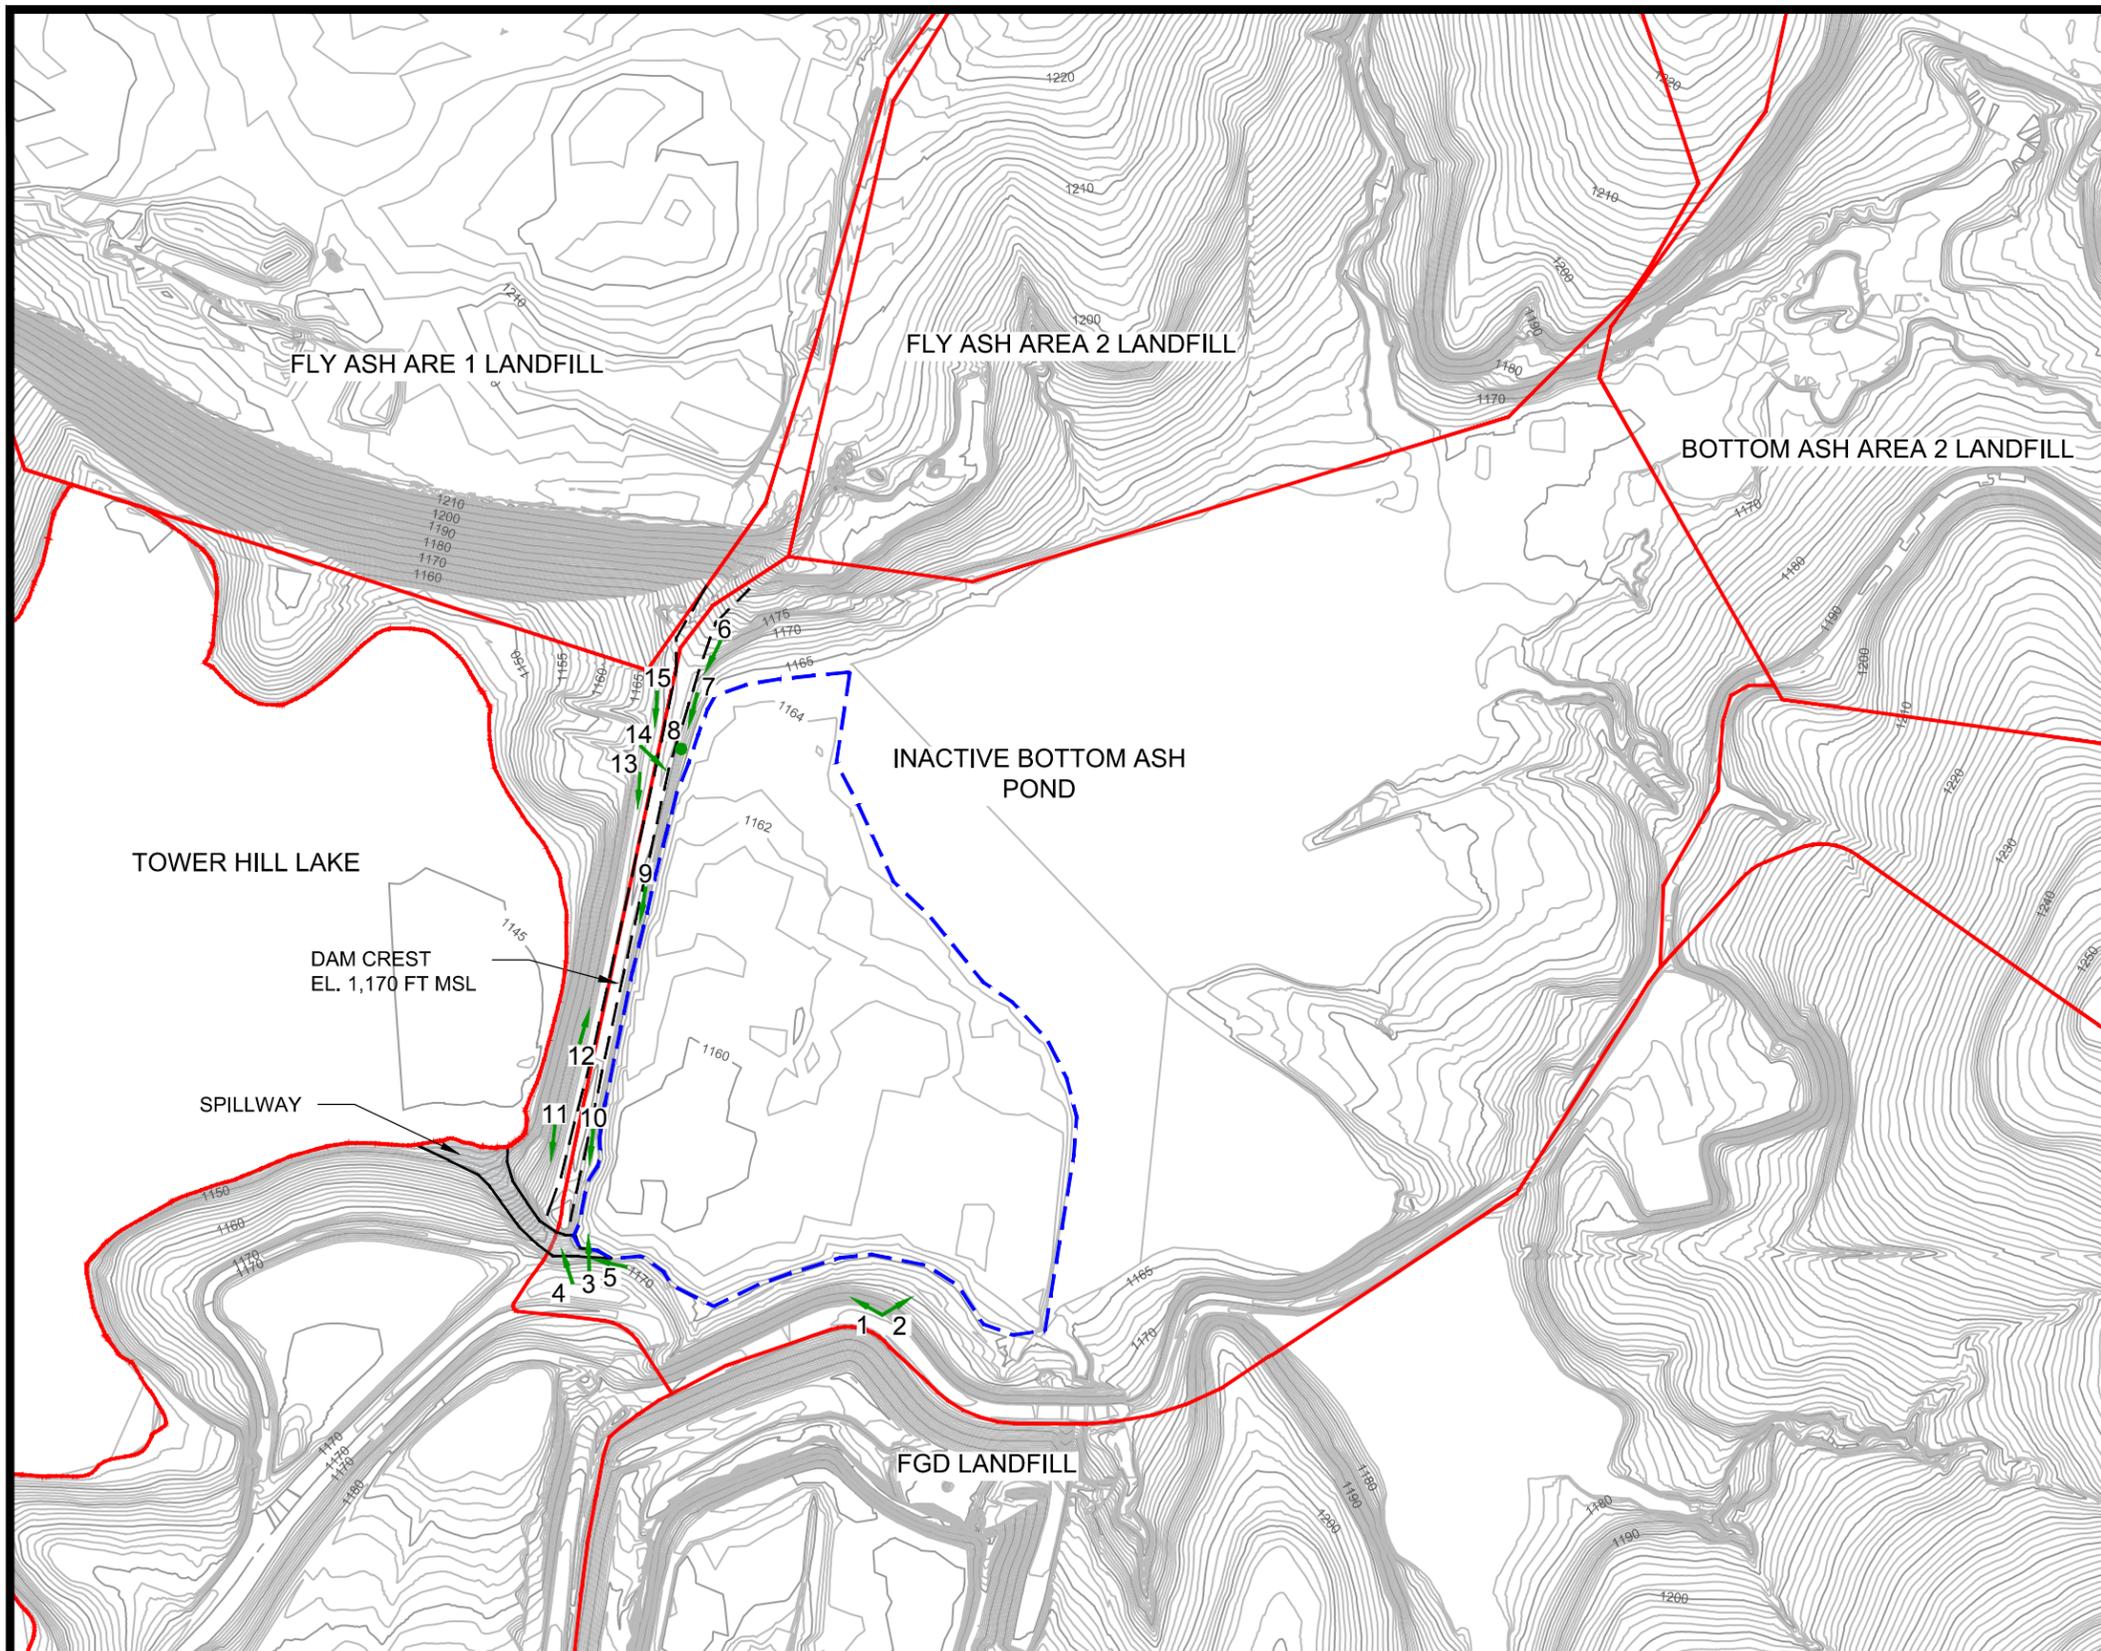
FIGURE 3
INACTIVE BOTTOM ASH POND
PHOTO LOG

At the time of inspection, stormwater conveyance systems such as the Pond stormwater drainage channels and the Pond Dam spillway were operating as designed with no observed deficiencies. Photographs 3 through 5 in **Appendix A**, depict the spillway's location with discharge appropriately moving from the Pond to Tower Hill Lake. No signs of erosion or malfunction were detected in these features.

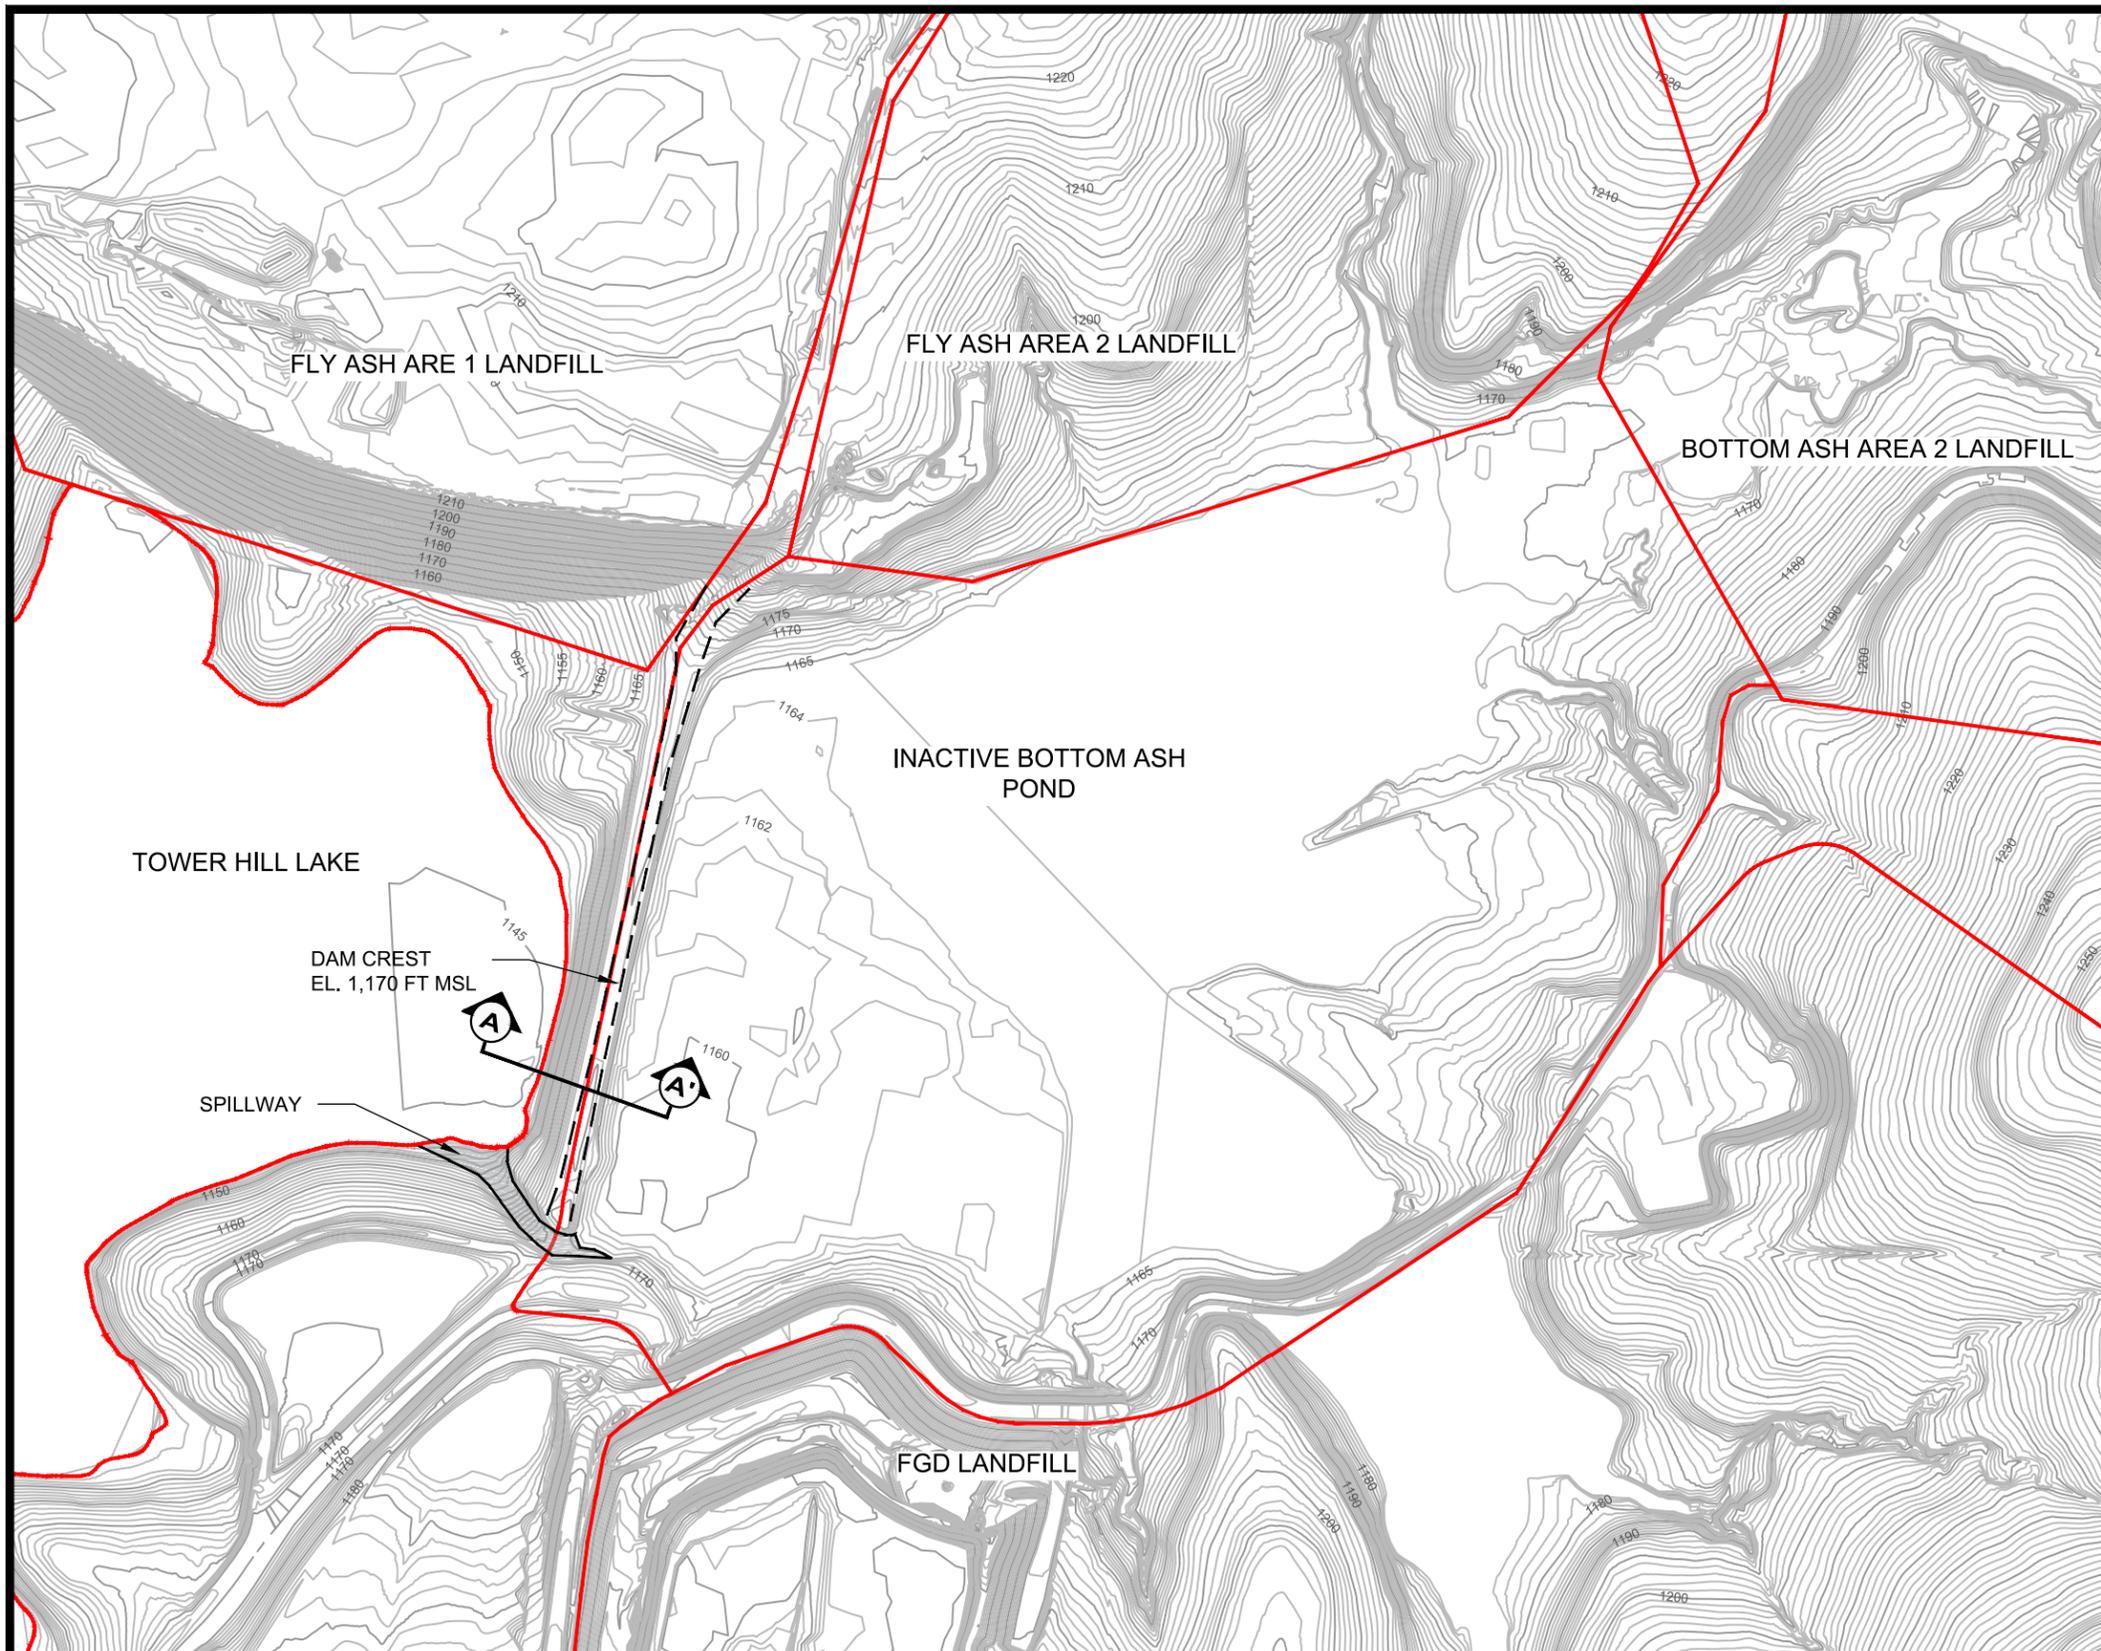
FIGURE 4
INACTIVE BOTTOM ASH POND
APPROXIMATE CROSS-SECTION LOCATION

Cross section A-A' is a schematic, critical cross-section which incorporates the section of the Pond Dam most susceptible to structural failure, as required by §257.73(e)(1). It conservatively captures the area with the highest potential for failure based on the embankment geometry, water levels, and subsurface soil conditions. The cross-section is based on the cross-section used in the 1999 stability assessment and updated with current elevations and conditions. The cross-section is characterized by the following features:

See **Figure 4** for the approximate cross-section location.

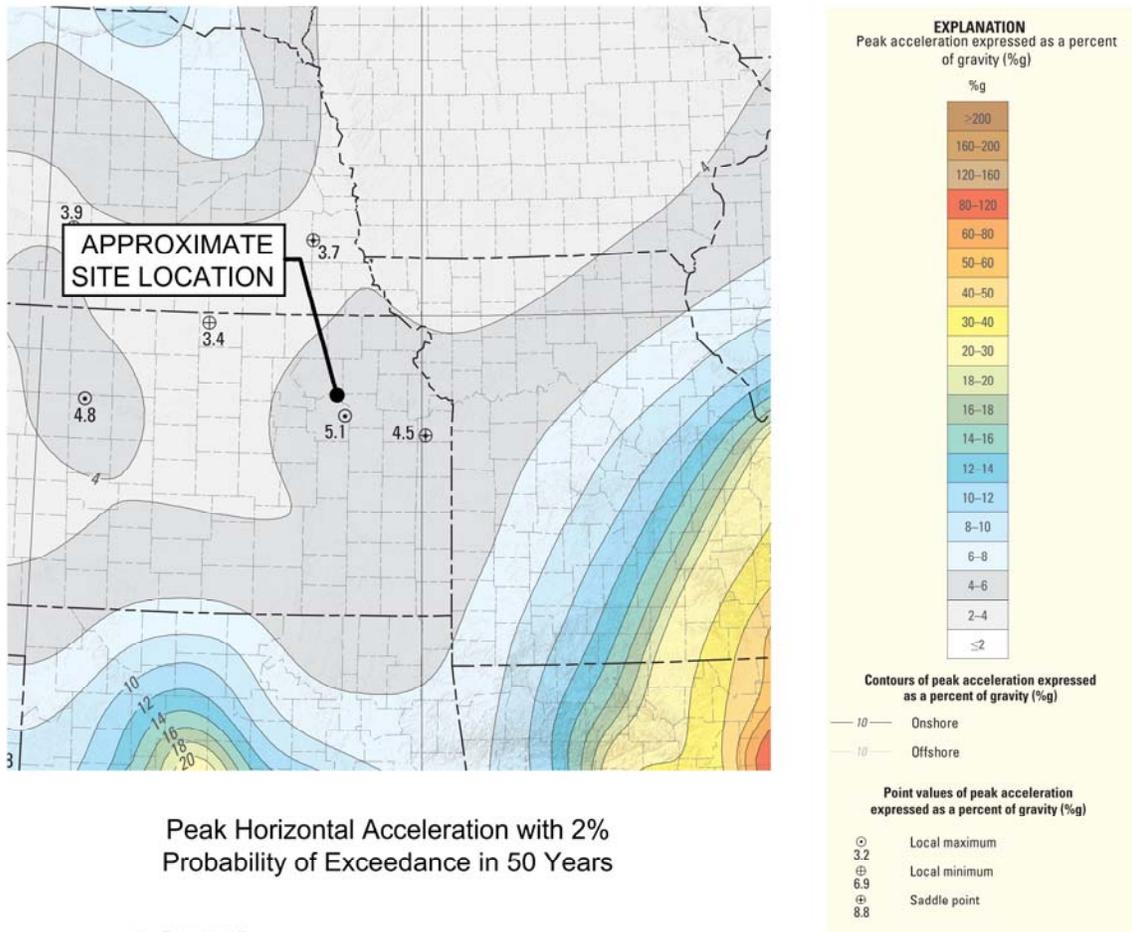
FIGURE 5
INACTIVE BOTTOM ASH POND
MAP OF HORIZONTAL ACCELERATION

As discussed in the preamble of the CCR Rule, all CCR surface impoundments must also be capable of withstanding a design earthquake without damage to the foundation or embankment that would cause a discharge of its contents. Specifically, it must be assessed to withstand “a seismic loading event with a 2% probability of exceedance in 50 years, equivalent to a return period of approximately 2,500 years, based on the USGS seismic hazard maps for seismic events with this return period for the region where the CCR unit is located”. Therefore the long-term maximum loading scenario was analyzed under a peak ground acceleration of 0.0485 g. The seismic acceleration is based on the USGS seismic hazard map for a 2 percent probability of exceedance in 50 years (see **Figure 5**).

P.E. %	Exp. Time (years)	Ground Motion (g)
2	50	0.0485
